Access Compliance Report

Public Rights-of-Way

(Curb Ramps)

Intersection ID: 10019873	Main Street: ARCHDALE_DR	Cross Street: N/A	Location: SW
ADA ID: B60744373CF4	Ramp Type: PerpDiag	Initial Pass/Fail: Fail	Overall Compliance: No
Severity Score: 37.5			
Codes/Mitigation Info/Possible Solution		Field Measurements/Component Compliance

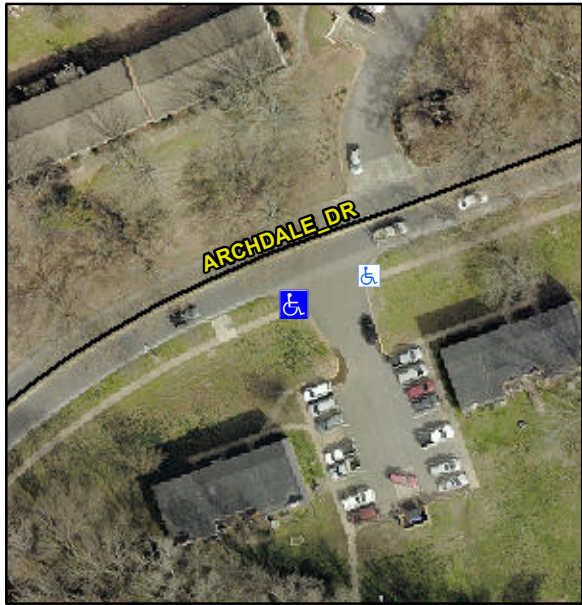
Not Found, R304.2.2, R304.5.3

Compliance	Description	Data	Compliance	Description	Data
N/A	Ramp Length (in)	30.0	No	Ramp Slope (%)	12.1
Yes	Ramp Width (in)	48.0	No	Ramp XSlope (%)	6.0
N/A	Flare Type LT	N/A	N/A	Flare Type RT	N/A
N/A	Flare Slope LT (%)	N/A	N/A	Flare Slope RT (%)	N/A
N/A	Flare Traversable LT?	N/A	N/A	Flare Traversable RT?	N/A
N/A	Landing Length (in)	N/A	N/A	DWS Provided?	N/A
N/A	Landing Width (in)	N/A	N/A	DWS Contrast?	N/A
N/A	Landing Slope (%)	N/A	N/A	DWS Length (in)	N/A
N/A	Landing X Slope (%)	N/A	N/A	DWS Full Width?	N/A
N/A	Landing Curb? (Y/N)	N/A	N/A	DWS Offset (in)	N/A
N/A	Shared Landing?	N/A			
N/A	Gutter Ponding?	N/A	N/A	Gutter Slope (%)	N/A
N/A	Gutter Lip Ht (in)	N/A	N/A	Gutter X Slope (%)	N/A
N/A	Painted X Walk1?	No	N/A	Painted X Walk2?	No
	X Walk 1 Direction	To E		X Walk 2 Direction	To N
N/A	X Walk 1 Width (in)	N/A	N/A	X Walk 2 Width (in)	N/A
	X Walk 1 Slope (%)	3.8		X Walk 2 Slope (%)	5.6
	X Walk 1 X Slope (%)	1.8		X Walk 2 X Slope (%)	1.6

N/A	Ramp inside XWalk1?	N/A	N/A	Ramp inside XWalk2?	N/A
	Road Slope (%)	0.2	N/A	Clear Space?	N/A
	Road X Slope (%)	3.0	N/A	Clear Space to XWalk (in)	N/A
N/A	Any Obstructions?	N/A	N/A	Storm Grate/Utility Hazard?	N/A
	Obstruction Type			Storm Grate/Utility Type	
		N/A			N/A
			Yes	Surface Condition? (G/P)	Good

Possible Solutions:

Remove & Replace Curb Ramp With Two New Directional Ramps or Equivalent.

Total Cost:\$3200.00
