# Access Compliance Report

## Public Rights-of-Way

### (Curb Ramps)

Intersection ID: 22902	Main Street: CARMEL_RD	Cross Street: MOORLAND_DR	Location: NE
ADA ID: B618BA665CB6	Ramp Type: PerpDiag	Initial Pass/Fail: Fail	Overall Compliance: No
		Severity Score: 12.5

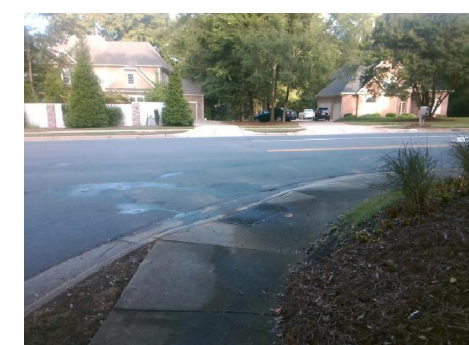
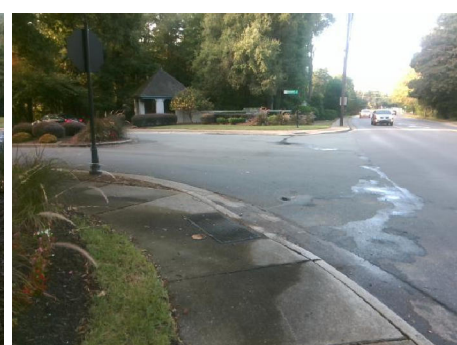
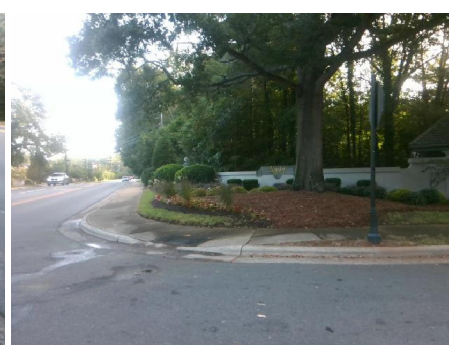
Possible Solutions:		<b>Compliance</b>	<b>Description</b>	<b>Data</b>
	<b>Remove &amp; Replace Curb Ramp With Two New Directional Ramps or Equivalent.</b>		N/A	Ramp Length (in)	69.0
			Yes	Ramp Width (in)	48.0
			N/A	Flare Type LT	N/A
			N/A	Flare Slope LT (%)	N/A
			N/A	Flare Traversable LT?	N/A
			N/A	Landing Length (in)	N/A
			N/A	Landing Width (in)	N/A
			N/A	Landing Slope (%)	N/A
			N/A	Landing X Slope (%)	N/A
			N/A	Landing Curb? (Y/N)	N/A
			N/A	Shared Landing?	N/A
			N/A	Gutter Ponding?	N/A
			N/A	Gutter Lip Ht (in)	N/A
			N/A	Painted X Walk1?	No
				X Walk 1 Direction	To NW
			N/A	X Walk 1 Width (in)	N/A
				X Walk 1 Slope (%)	0.0
				X Walk 1 X Slope (%)	0.8
			N/A	Ramp inside XWalk1?	N/A
<p>Surveyor Notes:</p> <p><b>N/A</b></p> <p>PROW/ADA:</p> <p><b>Not Found, R304.2.2</b></p>			N/A	Flare Type RT	N/A
			N/A	Flare Slope RT (%)	N/A

N/A	Flare Traversable RT?	N/A
			N/A	DWS Provided?	N/A
			N/A	DWS Contrast?	N/A
			N/A	DWS Length (in)	N/A
			N/A	DWS Full Width?	N/A
			N/A	DWS Offset (in)	N/A
			N/A	Gutter Slope (%)	N/A
			N/A	Gutter X Slope (%)	N/A
			N/A	Painted X Walk2?	No
				X Walk 2 Direction	To SW
			N/A	X Walk 2 Width (in)	N/A
				X Walk 2 Slope (%)	0.7
				X Walk 2 X Slope (%)	3.3
			N/A	Ramp inside XWalk2?	N/A
			N/A	Clear Space?	N/A
			N/A	Clear Space to XWalk (in)	N/A
			N/A	Storm Grate/Utility Hazard?	N/A
				Storm Grate/Utility Type	
<p>Total Cost:</p> <p>\$ 3200.00</p>			N/A		N/A
			Yes	Surface Condition? (G/P)	Good
