# Access Compliance Report

## Public Rights-of-Way

### (Curb Ramps)

Intersection ID: N/A	Main Street: E_4TH_ST	Cross Street: S_CALDWELL_ST	Location: E
ADA ID: B62B4E387BFD	Ramp Type: Perp	Initial Pass/Fail: Fail	Overall Compliance: No
		Severity Score: 35

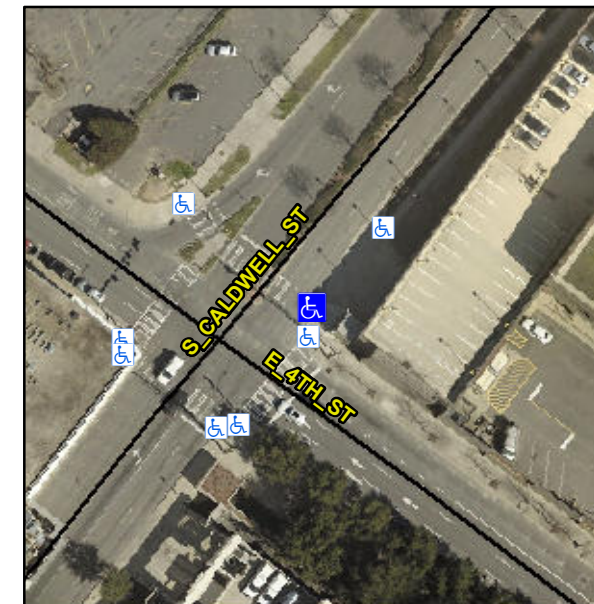
**Not Found, R304.5.1**

Compliance	Description	Data	Compliance	Description	Data
N/A	Ramp Length (in)	112.0	Yes	Ramp Slope (%)	7.4
No	Ramp Width (in)	24.0	Yes	Ramp XSlope (%)	0.5
N/A	Flare Type LT	N/A	N/A	Flare Type RT	N/A
N/A	Flare Slope LT (%)	N/A	N/A	Flare Slope RT (%)	N/A
N/A	Flare Traversable LT?	No	N/A	Flare Traversable RT?	No
N/A	Landing Length (in)	N/A	N/A	DWS Provided?	N/A
N/A	Landing Width (in)	N/A	N/A	DWS Contrast?	N/A
N/A	Landing Slope (%)	N/A	N/A	DWS Length (in)	N/A
N/A	Landing X Slope (%)	N/A	N/A	DWS Full Width?	N/A
N/A	Landing Curb? (Y/N)	N/A	N/A	DWS Offset (in)	N/A
N/A	Shared Landing?	N/A			
N/A	Gutter Ponding?	N/A	N/A	Gutter Slope (%)	N/A
N/A	Gutter Lip Ht (in)	N/A	N/A	Gutter X Slope (%)	N/A
N/A	Painted X Walk1?	Yes	N/A	Painted X Walk2?	N/A
	X Walk 1 Direction	To NW		X Walk 2 Direction	N/A
N/A	X Walk 1 Width (in)	120.0	N/A	X Walk 2 Width (in)	N/A
	X Walk 1 Slope (%)	1.6		X Walk 2 Slope (%)	N/A
	X Walk 1 X Slope (%)	2.1		X Walk 2 X Slope (%)	N/A

N/A	Ramp inside XWalk1?	Yes	N/A	Ramp inside XWalk2?	N/A
	Road Slope (%)	N/A	N/A	Clear Space?	N/A
	Road X Slope (%)	N/A	N/A	Clear Space to XWalk (in)	N/A
N/A	Any Obstructions?	N/A	N/A	Storm Grate/Utility Hazard?	N/A
	Obstruction Type			Storm Grate/Utility Type	
		N/A			N/A
			Yes	Surface Condition? (G/P)	Good

Possible Solutions:

**Remove & Replace Entire Ramp.**

Total Cost: \$ 1850.00
