## Access Compliance Report Public Rights-of-Way (Curb Ramps)

· · · ·							
Intersection ID: 22517 Main S	Main Street: EL_VERANO_CR		Cross Street: SHARON_LAKES_RD			Location:	NE
ADA ID: B62C4993E8AB Ramp	993E8AB Ramp Type: PerpDiag		Initial Pass/Fail: Fail Overall Compliance: N			o Severity Score:	26.25
Codes/Mitigation Info/Possible Solution		Field Measurements/Component Compliance					
P P P P P P P P P P P P P P P P P P P	Possible Solutions:	Com			Compliance Description		Data
	Remove & Replace Curb Ramp W	/ith N/A	Ramp Length (in)	48.0	No	Ramp Slope (%)	18.5
	Two New Directional Ramps or	Yes	Ramp Width (in)	48.0	No	Ramp XSlope (%)	4.8
	Equivalent.	N/A	Flare Type LT	N/A	N/A	Flare Type RT	N/A
		N/A	Flare Slope LT (%)	N/A	N/A	Flare Slope RT (%)	N/A
		N/A	Flare Traversable LT?	N/A	N/A	Flare Traversable RT?	N/A
	2	N/A	Landing Length (in)	N/A	N/A	DWS Provided?	N/A
	Surveyor Notes:	N/A	Landing Width (in)	N/A	N/A	DWS Contrast?	N/A
	N/A	N/A	Landing Slope (%)	N/A	N/A	DWS Length (in)	N/A

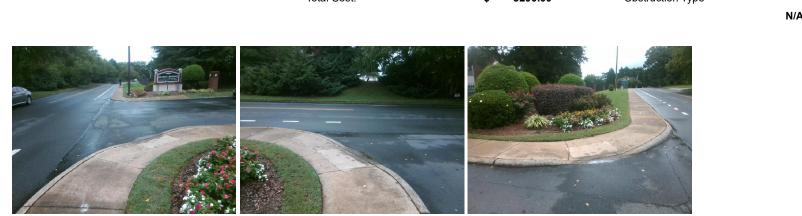
N/A	Landing X Slope (%)	N/A	N/A	DWS Full Width?	N/A
		N/A	Landing Curb? (Y/N)	N/A	N/A	DWS Offset (in)	N/A
		N/A	Shared Landing?	N/A			
	PROW/ADA:	N/A	Gutter Ponding?	N/A	N/A	Gutter Slope (%)	N/A
	Not Found, R304.2.2, R304.5.3	N/A	Gutter Lip Ht (in)	N/A	N/A	Gutter X Slope (%)	N/A
		N/A	Painted X Walk1?	No	N/A	Painted X Walk2?	No
	¢		X Walk 1 Direction	To W		X Walk 2 Direction	To S
1 (1) (1) (1) (1) (1) (1) (1) (1) (1)	P.,	N/A	X Walk 1 Width (in)	N/A	N/A	X Walk 2 Width (in)	N/A
Street 1 Name EL VERANO CR	—		X Walk 1 Slope (%)	4.7		X Walk 2 Slope (%)	2.8
Stop Condition-Street 2 None			X Walk 1 X Slope (%)	0.6		X Walk 2 X Slope (%)	5.6
Street 2 Name SHARON LAKES RD		N/A	Ramp inside XWalk1?	N/A	N/A	Ramp inside XWalk2?	N/A
Stop Condition-Street 1 None			Road Slope (%)	0.1	N/A	Clear Space?	N/A
			Road X Slope (%)	1.4	N/A	Clear Space to XWalk (in)	N/A
		N/A	Any Obstructions?	N/A	N/A	Storm Grate/Utility Hazard?	N/A

Yes Surface Condition? (G/P)

Good

Total Cost: \$ 32	200.00	Obstruction Type			Storm Grate/Utility Type	
				N/A			N/A
