# Access Compliance Report

## Public Rights-of-Way

### (Curb Ramps)

Intersection ID: 16232	Main Street: ANSON_ST	Cross Street: HOLLIS_RD	Location: N
ADA ID: B63DB72F2416	Ramp Type: Directional1	Initial Pass/Fail: Fail	Overall Compliance: No
		Severity Score: 1.25

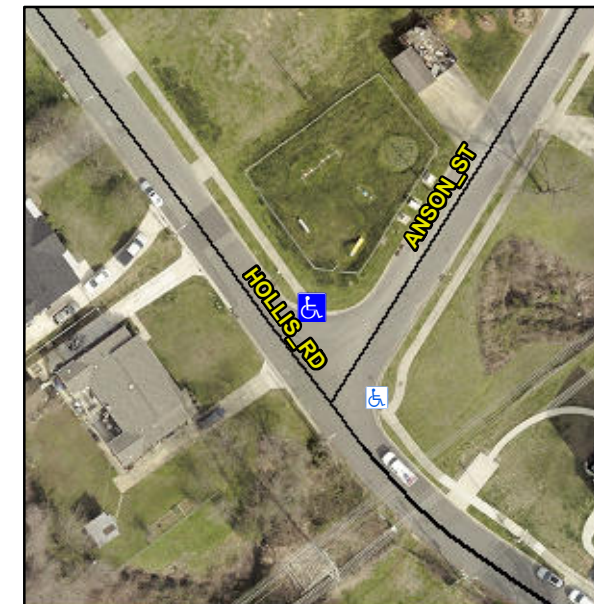
Compliance	Description	Data	Compliance	Description	Data
N/A	Ramp Length (in)	62.0	N/A	Grade Break?	N/A
Yes	Ramp Width (in)	59.0	N/A	Grade Break Slope (%)	0.0
Yes	Ramp Slope (%)	1.1	N/A	Grade Break XSlope (%)	0.0
No	Ramp XSlope (%)	3.6			
N/A	Flare Type LT	N/A	N/A	Flare Type RT	N/A
N/A	Flare Slope LT (%)	N/A	N/A	Flare Slope RT (%)	0.0
N/A	Flare Traversable LT?	N/A	N/A	Flare Traversable RT?	N/A
N/A	Landing Length (in)	0.0	N/A	DWS Provided?	N/A
N/A	Landing Width (in)	0.0	N/A	DWS Contrast?	N/A
N/A	Landing Slope (%)	0.0	N/A	DWS Length (in)	N/A
N/A	Landing X Slope (%)	0.0	N/A	DWS Full Width?	N/A
N/A	Landing Curb? (Y/N)	N/A	N/A	DWS Offset LT (in)	N/A
N/A	Shared Landing?	N/A	N/A	DWS Offset RT (in)	N/A
N/A	Gutter Ponding?	0.0	N/A	Gutter Slope (%)	N/A
N/A	Gutter Lip Ht (in)	0.0	N/A	Gutter X Slope (%)	N/A
N/A	Painted X Walk1?	No		Road Slope (%)	3.4
	X Walk 1 Direction	To SE		Road X Slope (%)	1.7
	X Walk 1 Width (in)	N/A		Clear Space?	N/A

X Walk 1 Slope (%)	3.4	N/A	Clear Space to XWalk (in)	N/A
	X Walk 1 X Slope (%)	1.7	N/A	Storm Grate/Utility Hazard?	N/A
N/A	Ramp inside XWalk1?	N/A		Storm Grate/Utility Type	
N/A	Any Obstructions?	N/A			N/A
	Obstruction Type		Yes	Surface Condition? (G/P)	Good
			N/A	Curb Slope (%)	13.7

**Remove & Replace Entire Ramp.**

**R304.5.3**
