Access Compliance Report Public Rights-of-Way (Curb Ramps)

Intersection ID: 9848 Main Street: THE_PLAZA Cross Street: WILANN_DR Location: SE

ADA ID: B63DF15185F2 Ramp Type: PerpDiag Initial Pass/Fail: Fail Overall Compliance: No Severity Score: 13.75

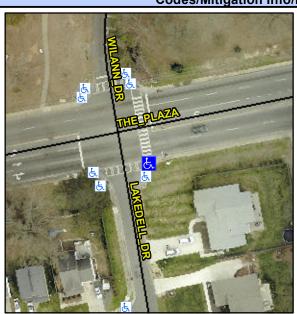
Field Measurements/Component Compliance						
Compliance Description		Data	Comp	oliance Description	Data	
1	N/A	Ramp Length (in)	62.0	No	Ramp Slope (%)	10.1
١	es/	Ramp Width (in)	48.0	Yes	Ramp XSlope (%)	3.8
N	I/A	Flare Type LT	N/A	N/A	Flare Type RT	N/A
1	N/A	Flare Slope LT (%)	N/A	N/A	Flare Slope RT (%)	N/A
1	N/A	Flare Traversable LT?	N/A	N/A	Flare Traversable RT?	N/A
1	N/A	Landing Length (in)	N/A	N/A	DWS Provided?	N/A
1	N/A	Landing Width (in)	N/A	N/A	DWS Contrast?	N/A
1	N/A	Landing Slope (%)	N/A	N/A	DWS Length (in)	N/A
1	N/A	Landing X Slope (%)	N/A	N/A	DWS Full Width?	N/A
1	N/A	Landing Curb? (Y/N)	N/A	N/A	DWS Offset (in)	N/A
1	N/A	Shared Landing?	N/A			
1	N/A	Gutter Ponding?	N/A	N/A	Gutter Slope (%)	N/A
N	I/A	Gutter Lip Ht (in)	N/A	N/A	Gutter X Slope (%)	N/A
1	N/A	Painted X Walk1?	Yes	N/A	Painted X Walk2?	Yes
		X Walk 1 Direction	To N		X Walk 2 Direction	To W
1	N/A	X Walk 1 Width (in)	100.5	N/A	X Walk 2 Width (in)	99.5

X Walk 1 Slope (%)	2.4		X Walk 2 Slope (%)	2.1
		X Walk 1 X Slope (%)	1.3		X Walk 2 X Slope (%)	3.0
1	N/A	Ramp inside XWalk1?	No	N/A	Ramp inside XWalk2?	No
		Road Slope (%)	4.0	N/A	Clear Space?	N/A
		Road X Slope (%)	3.4	N/A	Clear Space to XWalk (in)	N/A
1	N/A	Any Obstructions?	N/A	N/A	Storm Grate/Utility Hazard?	N/A
		Obstruction Type			Storm Grate/Utility Type	
			N/A			N/A
				Yes	Surface Condition? (G/P)	Good

Possible Solutions:

Remove & Replace Curb Ramp With
Two New Directional Ramps or
Equivalent. Restripe Crosswalk.
