# Access Compliance Report

## Public Rights-of-Way

### (Curb Ramps)

Intersection ID: 3097	Main Street: PLACER MAPLE LN	Cross Street: ALLEN A BROWN RD	Location: SE
ADA ID: B6449FD72ABB	Ramp Type: Perp	Initial Pass/Fail: Fail	Overall Compliance: No
Codes/Mitigation Info/Possible Solution			Severity Score: 10
			Field Measurements/Component Compliance

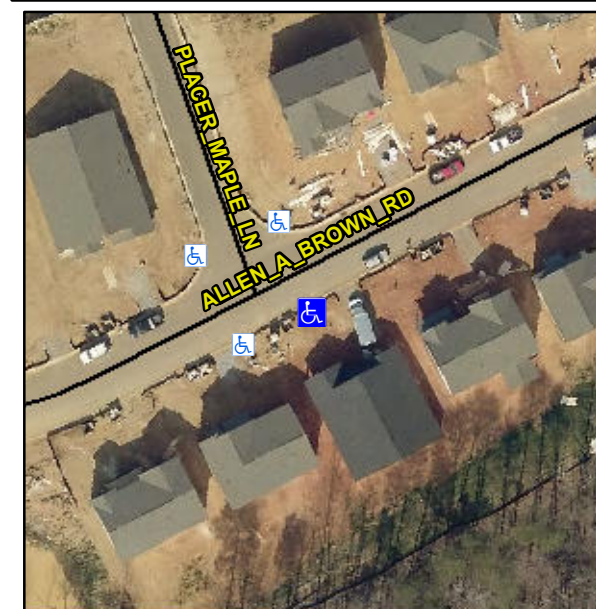
**Not Found, R304.5.1**

Compliance	Description	Data	Compliance	Description	Data
N/A	Ramp Length (in)	48.0	Yes	Ramp Slope (%)	6.7
No	Ramp Width (in)	47.0	Yes	Ramp XSlope (%)	2.4
N/A	Flare Type LT	N/A	N/A	Flare Type RT	N/A
N/A	Flare Slope LT (%)	N/A	N/A	Flare Slope RT (%)	N/A
N/A	Flare Traversable LT?	N/A	N/A	Flare Traversable RT?	N/A
N/A	Landing Length (in)	N/A	N/A	DWS Provided?	N/A
N/A	Landing Width (in)	N/A	N/A	DWS Contrast?	N/A
N/A	Landing Slope (%)	N/A	N/A	DWS Length (in)	N/A
N/A	Landing X Slope (%)	N/A	N/A	DWS Full Width?	N/A
N/A	Landing Curb? (Y/N)	N/A	N/A	DWS Offset (in)	N/A
N/A	Shared Landing?	N/A			
N/A	Gutter Ponding?	N/A	N/A	Gutter Slope (%)	N/A
N/A	Gutter Lip Ht (in)	N/A	N/A	Gutter X Slope (%)	N/A
N/A	Painted X Walk1?	No	N/A	Painted X Walk2?	N/A
	X Walk 1 Direction	To N		X Walk 2 Direction	N/A
N/A	X Walk 1 Width (in)	N/A	N/A	X Walk 2 Width (in)	N/A
	X Walk 1 Slope (%)	3.7		X Walk 2 Slope (%)	N/A
	X Walk 1 X Slope (%)	5.2		X Walk 2 X Slope (%)	N/A

N/A	Ramp inside XWalk1?	N/A	N/A	Ramp inside XWalk2?	N/A
	Road Slope (%)	N/A	N/A	Clear Space?	N/A
	Road X Slope (%)	N/A	N/A	Clear Space to XWalk (in)	N/A
N/A	Any Obstructions?	N/A	N/A	Storm Grate/Utility Hazard?	N/A
	Obstruction Type			Storm Grate/Utility Type	
		N/A			N/A
			Yes	Surface Condition? (G/P)	Good

Possible Solutions:

**Remove & Replace Entire Ramp.**

Total Cost: \$ 1850.00
