| Intersection ID: 48959 | Main Street: FRANKLIN_SQUARE_RD | Cross Street: PERRY_JUNE_AV | Location: | SE |
| ADA ID: B66860B673F6 | Ramp Type: Perp | Initial Pass/Fail: Pass | Overall Compliance: No | Severity Score: 20.25 |

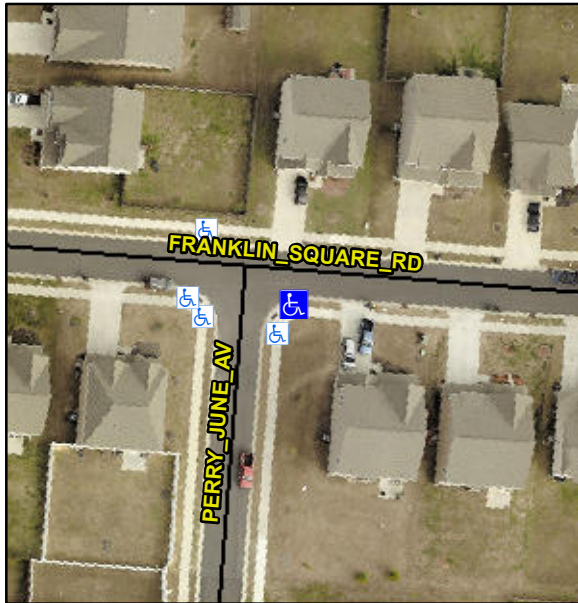
**Not Found, R305.2, R302.7.2,  
R304.5.4**

| Compliance | Description | Data | Compliance | Description | Data |
|---|---|---|---|---|---|
| N/A | Landing Curb? (Y/N) | No | No | DWS Offset (in) | 4.0 |
| Yes | Gutter Ponding? | No | No | Gutter Slope (%) | 8.2 |
| No | Gutter Lip Ht (in) | 1.0 | Yes | Gutter X Slope (%) | 0.9 |

**Remove & Replace Entire Ramp.  
Remove & Replace Gutter.**

**Total Cost: \$ 2600.00**

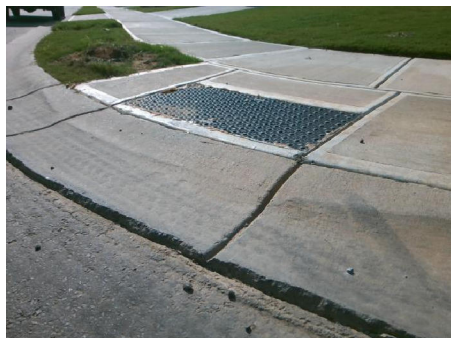
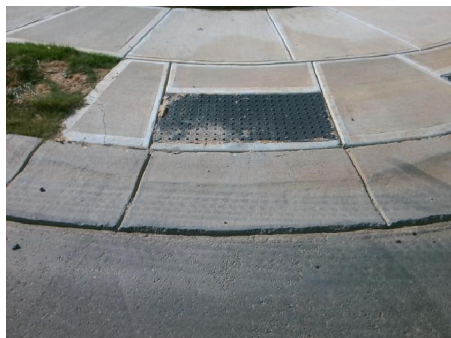
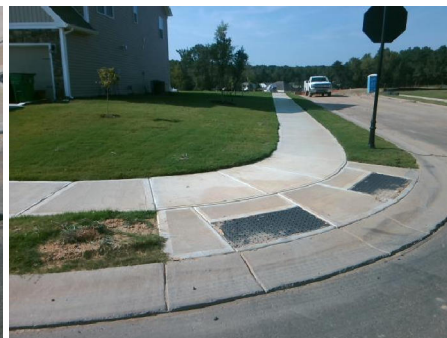
| Compliance | Description | Data | Compliance | Description | Data |
|---|---|---|---|---|---|
| N/A | Ramp Length (in) | 47.5 | Yes | Ramp Slope (%) | 6.1 |
| Yes | Ramp Width (in) | 48.0 | Yes | Ramp XSlope (%) | 2.1 |
