Access Compliance Report

Public Rights-of-Way

(Curb Ramps)

Intersection ID: 14212	Main Street: HAWKINS_ST	Cross Street: W_TREMONT_AV	Location: NW
ADA ID: B66F6E9114CD	Ramp Type: PerpDiag	Initial Pass/Fail: Fail	Overall Compliance: No
Severity Score: 12.5			
Codes/Mitigation Info/Possible Solution		Field Measurements/Component Compliance

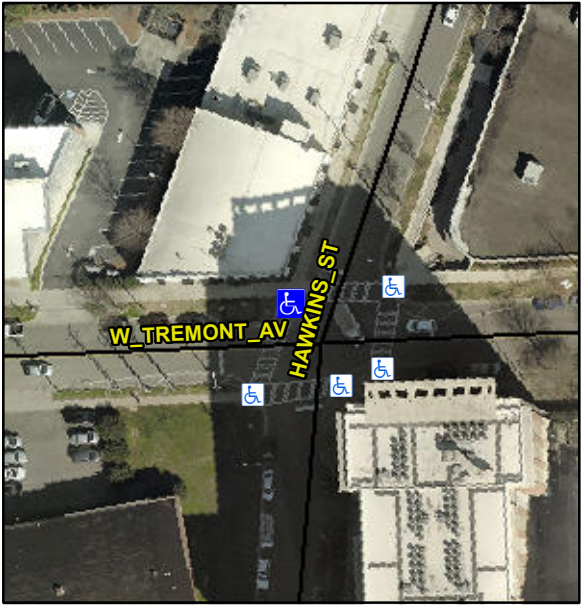
Possible Solutions:						
	Remove & Replace Curb Ramp With Two New Directional Ramps or Equivalent.						
	Surveyor Notes:						
	N/A						
	PROW/ADA:						
	Not Found, R304.5.3						
				Compliance	Description	Data	Compliance
				Description	Data		Description
				Data			Data
		N/A	Ramp Length (in)	91.0	Yes	Ramp Slope (%)	5.6
		Yes	Ramp Width (in)	179.0	No	Ramp XSlope (%)	5.5
		N/A	Flare Type LT	N/A	N/A	Flare Type RT	N/A
		N/A	Flare Slope LT (%)	N/A	N/A	Flare Slope RT (%)	N/A
		N/A	Flare Traversable LT?	N/A	N/A	Flare Traversable RT?	N/A
		N/A	Landing Length (in)	N/A	N/A	DWS Provided?	N/A
		N/A	Landing Width (in)	N/A	N/A	DWS Contrast?	N/A
		N/A	Landing Slope (%)	N/A	N/A	DWS Length (in)	N/A
		N/A	Landing X Slope (%)	N/A	N/A	DWS Full Width?	N/A
		N/A	Landing Curb? (Y/N)	N/A	N/A	DWS Offset (in)	N/A
		N/A	Shared Landing?	N/A			
		N/A	Gutter Ponding?	N/A	N/A	Gutter Slope (%)	N/A
		N/A	Gutter Lip Ht (in)	N/A	N/A	Gutter X Slope (%)	N/A

N/A	Painted X Walk1?	Yes	N/A	Painted X Walk2?	No
			X Walk 1 Direction	To S		X Walk 2 Direction	To E
		N/A	X Walk 1 Width (in)	90.0	N/A	X Walk 2 Width (in)	N/A
			X Walk 1 Slope (%)	4.1		X Walk 2 Slope (%)	5.7
			X Walk 1 X Slope (%)	5.4		X Walk 2 X Slope (%)	1.5
		N/A	Ramp inside XWalk1?	Yes	N/A	Ramp inside XWalk2?	N/A
			Road Slope (%)	5.1	N/A	Clear Space?	N/A
			Road X Slope (%)	5.5	N/A	Clear Space to XWalk (in)	N/A
		N/A	Any Obstructions?	N/A	N/A	Storm Grate/Utility Hazard?	N/A
			Obstruction Type			Storm Grate/Utility Type	
					N/A		N/A
		Yes	Surface Condition? (G/P)	Good			
Total Cost:		\$ 3200.00
