Access Compliance Report

Public Rights-of-Way

(Curb Ramps)

Intersection ID: 43744	Main Street: RED_CLAY_LN	Cross Street: EARTHENWARE_DR	Location: E
ADA ID: B673872A774A	Ramp Type: PerpDiag	Initial Pass/Fail: Fail	Overall Compliance: No
Severity Score: 33.75			
Codes/Mitigation Info/Possible Solution		Field Measurements/Component Compliance

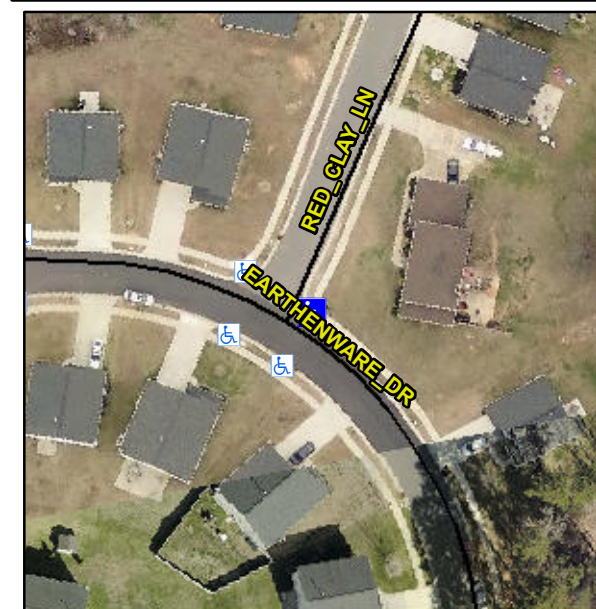
Compliance	Description	Data	Compliance	Description	Data
N/A	Ramp Length (in)	50.0	No	Ramp Slope (%)	18.1
No	Ramp Width (in)	46.5	Yes	Ramp XSlope (%)	0.8
N/A	Flare Type LT	N/A	N/A	Flare Type RT	N/A
N/A	Flare Slope LT (%)	N/A	N/A	Flare Slope RT (%)	N/A
N/A	Flare Traversable LT?	N/A	N/A	Flare Traversable RT?	N/A
N/A	Landing Length (in)	N/A	N/A	DWS Provided?	N/A
N/A	Landing Width (in)	N/A	N/A	DWS Contrast?	N/A
N/A	Landing Slope (%)	N/A	N/A	DWS Length (in)	N/A
N/A	Landing X Slope (%)	N/A	N/A	DWS Full Width?	N/A
N/A	Landing Curb? (Y/N)	N/A	N/A	DWS Offset (in)	N/A
N/A	Shared Landing?	N/A			
N/A	Gutter Ponding?	N/A	N/A	Gutter Slope (%)	N/A
N/A	Gutter Lip Ht (in)	N/A	N/A	Gutter X Slope (%)	N/A
N/A	Painted X Walk1?	No	N/A	Painted X Walk2?	No
	X Walk 1 Direction	To NW		X Walk 2 Direction	To SW
N/A	X Walk 1 Width (in)	N/A	N/A	X Walk 2 Width (in)	N/A
	X Walk 1 Slope (%)	2.1		X Walk 2 Slope (%)	2.1
	X Walk 1 X Slope (%)	3.1		X Walk 2 X Slope (%)	2.3

N/A	Ramp inside XWalk1?	N/A	N/A	Ramp inside XWalk2?	N/A
	Road Slope (%)	1.3	N/A	Clear Space?	N/A
	Road X Slope (%)	3.0	N/A	Clear Space to XWalk (in)	N/A
N/A	Any Obstructions?	N/A	N/A	Storm Grate/Utility Hazard?	N/A
	Obstruction Type			Storm Grate/Utility Type	
		N/A			N/A
		Yes		Surface Condition? (G/P)	Good

Possible Solutions:

Remove & Replace Curb Ramp With Two New Directional Ramps or Equivalent.
