# Access Compliance Report

## Public Rights-of-Way

### (Curb Ramps)

| Intersection ID: 11140 | Main Street: N_SYCAMORE_ST | Cross Street: W_5TH_ST | Location: SW |

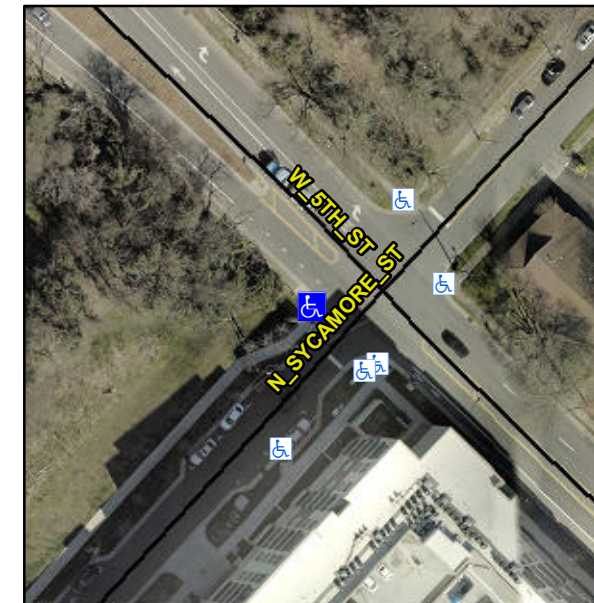
**LT RP < 5%**

**Not Found, R304.2.1, R305.2, R304.5.3**

| Compliance | Description | Data | Compliance | Description | Data |
|---|---|---|---|---|---|
| No | Landing Length (in) | 43.0 | Yes | DWS Provided? | Yes |
| No | Landing Width (in) | 47.0 | Yes | DWS Contrast? | Yes |
| N/A | Landing Curb? (Y/N) | No | No | DWS Offset (in) | 2.5 |
| Yes | Gutter Lip Ht (in) | 0.0 | No | Gutter X Slope (%) | 2.2 |

**Remove & Replace Curb Ramp With Two New Directional Ramps or Equivalent. Remove & Replace Gutter.**

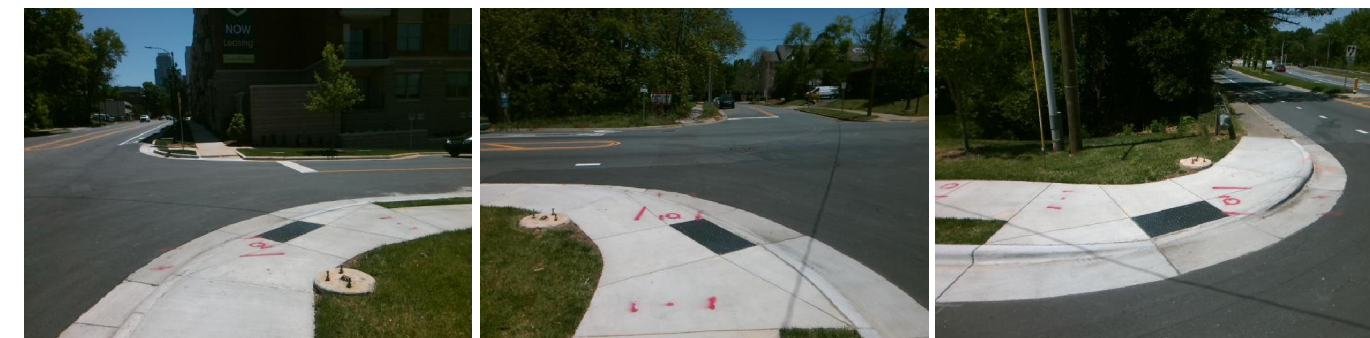
| Compliance | Description | Data | Compliance | Description | Data |
|---|---|---|---|---|---|
| | | | Replace | Curb Slope (%) | 12.6 |
