Access Compliance Report Public Rights-of-Way (Curb Ramps)

Intersection ID: 8565 Main Street: DRURY_DR Cross Street: HYDE_DR Location: SE

ADA ID: B680F87C3EE1 Ramp Type: Combination1 Initial Pass/Fail: Fail Overall Compliance: No Severity Score: 22.5

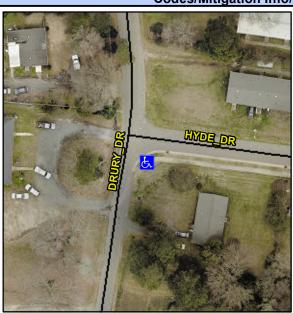
Street 1 Name
StopSign
Stop Condition-Street 1
HYDE DR
Street 2 Name
N/A
Stop Condition-Street 2
N/A

Remove & Replace Entire Ramp.

Not Found, R304.5.1, R304.5.1, R304.5.3, R304.3.2
