Access Compliance Report

Public Rights-of-Way

(Curb Ramps)

Intersection ID: 10041415	Main Street: WESTHALL_DR	Cross Street: N/A	Location: S
ADA ID: B6819B03A910	Ramp Type: PerpDiag	Initial Pass/Fail: Fail	Overall Compliance: No
Severity Score: 10			
Codes/Mitigation Info/Possible Solution		Field Measurements/Component Compliance

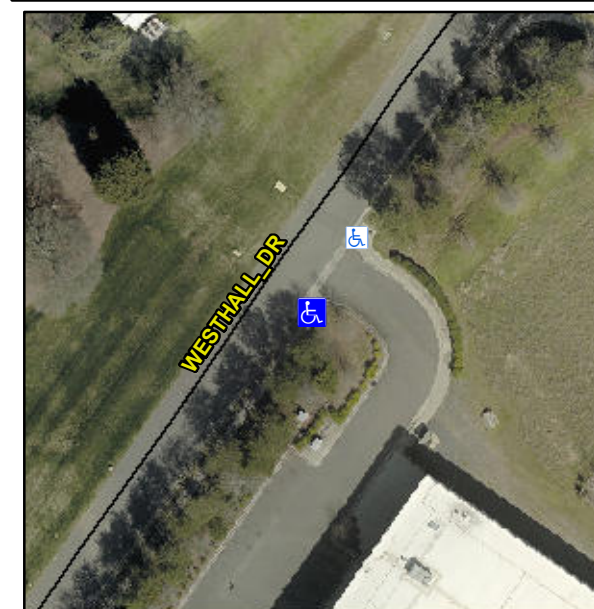
Not Found, R304.5.1, R304.5.3

Compliance	Description	Data	Compliance	Description	Data
N/A	Ramp Length (in)	111.0	Yes	Ramp Slope (%)	5.2
No	Ramp Width (in)	45.5	No	Ramp XSlope (%)	2.3
N/A	Flare Type LT	N/A	N/A	Flare Type RT	N/A
N/A	Flare Slope LT (%)	N/A	N/A	Flare Slope RT (%)	N/A
N/A	Flare Traversable LT?	N/A	N/A	Flare Traversable RT?	N/A
N/A	Landing Length (in)	N/A	N/A	DWS Provided?	N/A
N/A	Landing Width (in)	N/A	N/A	DWS Contrast?	N/A
N/A	Landing Slope (%)	N/A	N/A	DWS Length (in)	N/A
N/A	Landing X Slope (%)	N/A	N/A	DWS Full Width?	N/A
N/A	Landing Curb? (Y/N)	N/A	N/A	DWS Offset (in)	N/A
N/A	Shared Landing?	N/A			
N/A	Gutter Ponding?	N/A	N/A	Gutter Slope (%)	N/A
N/A	Gutter Lip Ht (in)	N/A	N/A	Gutter X Slope (%)	N/A
N/A	Painted X Walk1?	No	N/A	Painted X Walk2?	No
	X Walk 1 Direction	To NE		X Walk 2 Direction	To NW
N/A	X Walk 1 Width (in)	N/A	N/A	X Walk 2 Width (in)	N/A
	X Walk 1 Slope (%)	2.1		X Walk 2 Slope (%)	3.2
	X Walk 1 X Slope (%)	5.5		X Walk 2 X Slope (%)	1.3

N/A	Ramp inside XWalk1?	N/A	N/A	Ramp inside XWalk2?	N/A
	Road Slope (%)	0.9	N/A	Clear Space?	N/A
	Road X Slope (%)	4.7	N/A	Clear Space to XWalk (in)	N/A
N/A	Any Obstructions?	N/A	N/A	Storm Grate/Utility Hazard?	N/A
	Obstruction Type			Storm Grate/Utility Type	
		N/A			N/A
			Yes	Surface Condition? (G/P)	Good

Remove & Replace Curb Ramp With Two New Directional Ramps or Equivalent.

Total Cost: \$ 3200.00

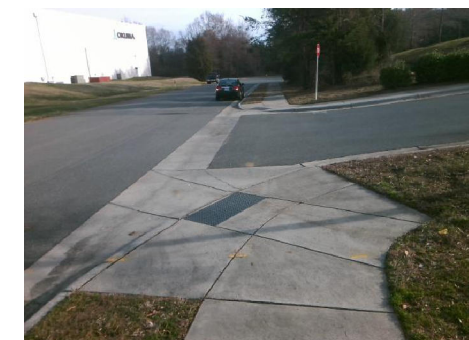
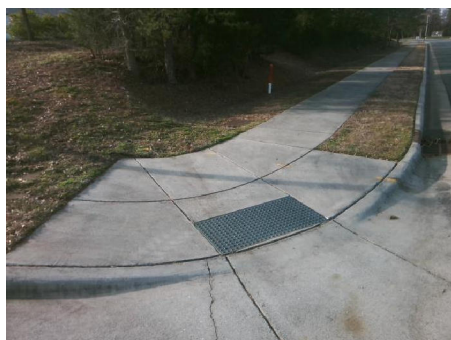
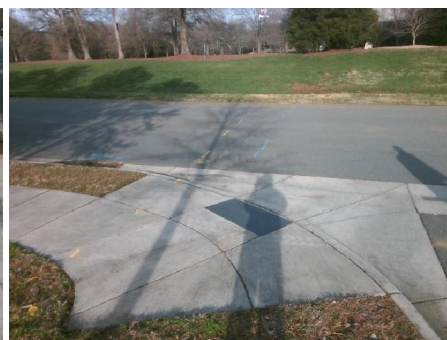
Street 1 Name **ENTRANCE**
 Stop Condition-Street 2 **StopSign**
 Street 2 Name **WESTHALL DR**
 Stop Condition-Street 1 **None**
