Access Compliance Report

Public Rights-of-Way

(Curb Ramps)

Intersection ID: N/A	Main Street: E MARTIN LUTHER KING JR BV	Cross Street: N/A	Location: S
ADA ID: B68C404A1F2E	Ramp Type: PerpDiag	Initial Pass/Fail: Fail	Overall Compliance: No
Severity Score: 12.5			
Codes/Mitigation Info/Possible Solution		Field Measurements/Component Compliance

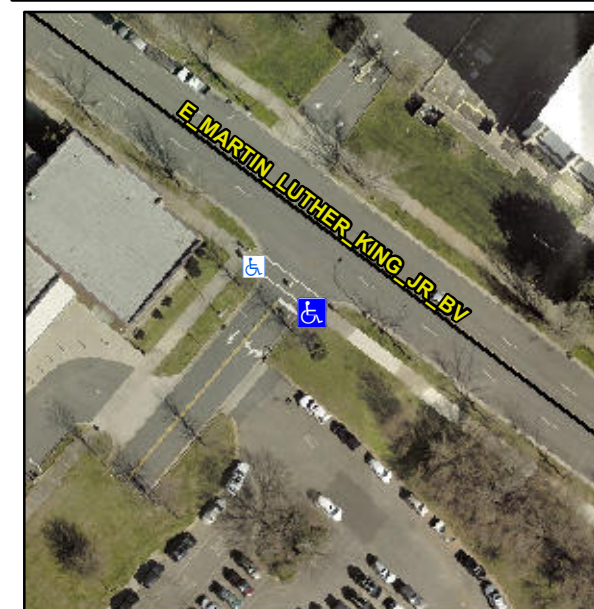
Compliance	Description	Data	Compliance	Description	Data
N/A	Ramp Length (in)	28.0	Yes	Ramp Slope (%)	5.2
Yes	Ramp Width (in)	97.0	No	Ramp XSlope (%)	5.1
N/A	Flare Type LT	N/A	N/A	Flare Type RT	N/A
N/A	Flare Slope LT (%)	N/A	N/A	Flare Slope RT (%)	N/A
N/A	Flare Traversable LT?	N/A	N/A	Flare Traversable RT?	N/A
N/A	Landing Length (in)	N/A	N/A	DWS Provided?	N/A
N/A	Landing Width (in)	N/A	N/A	DWS Contrast?	N/A
N/A	Landing Slope (%)	N/A	N/A	DWS Length (in)	N/A
N/A	Landing X Slope (%)	N/A	N/A	DWS Full Width?	N/A
N/A	Landing Curb? (Y/N)	N/A	N/A	DWS Offset (in)	N/A
N/A	Shared Landing?	N/A			
N/A	Gutter Ponding?	N/A	N/A	Gutter Slope (%)	N/A
N/A	Gutter Lip Ht (in)	N/A	N/A	Gutter X Slope (%)	N/A
N/A	Painted X Walk1?	Yes	N/A	Painted X Walk2?	No
	X Walk 1 Direction	To NE		X Walk 2 Direction	To NW
N/A	X Walk 1 Width (in)	90.0	N/A	X Walk 2 Width (in)	N/A
	X Walk 1 Slope (%)	4.0		X Walk 2 Slope (%)	0.6
	X Walk 1 X Slope (%)	2.1		X Walk 2 X Slope (%)	4.0

N/A	Ramp inside XWalk1?	Yes	N/A	Ramp inside XWalk2?	N/A
	Road Slope (%)	3.1	N/A	Clear Space?	N/A
	Road X Slope (%)	1.5	N/A	Clear Space to XWalk (in)	N/A
N/A	Any Obstructions?	N/A	N/A	Storm Grate/Utility Hazard?	N/A
	Obstruction Type			Storm Grate/Utility Type	
		N/A			N/A
		Yes		Surface Condition? (G/P)	Good

Possible Solutions:

Remove & Replace Curb Ramp With Two New Directional Ramps or Equivalent.

R304.5.3

\$ 3200.00
