# Access Compliance Report

## Public Rights-of-Way

| Intersection ID: 10037289 | Main Street: SARDIS_RD_NORTH | Cross Street: N/A | Location: N |
| ADA ID: B68C93EA6CFA | Ramp Type: Perp | Initial Pass/Fail: Fail | Overall Compliance: No |

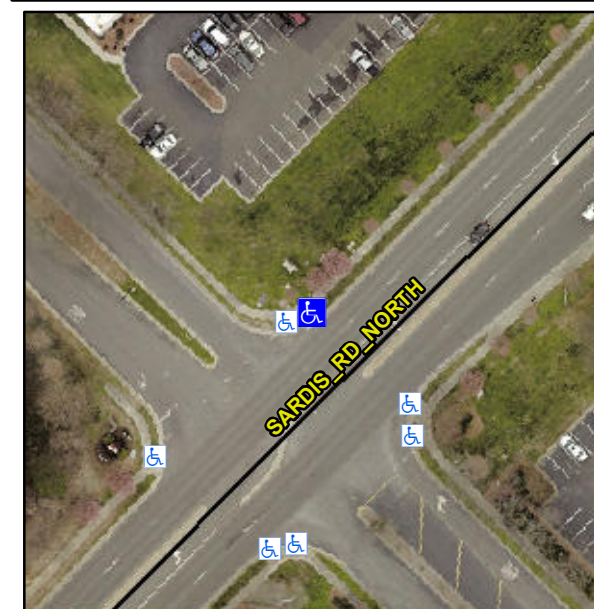
**R304.5.1, R304.5.3**

| Compliance | Description | Data | Compliance | Description | Data |
|---|---|---|---|---|---|
| N/A | Ramp Length (in) | 68.0 | Yes | Ramp Slope (%) | 6.5 |
| No | Ramp Width (in) | 43.0 | No | Ramp XSlope (%) | 3.6 |

**Remove & Replace Entire Ramp.**
