# Access Compliance Report

## Public Rights-of-Way (Curb Ramps)

Intersection ID: 25441	Main Street: PROVIDENCE PLANTATION LN	Cross Street: PROVIDENCE SPRING LN	Location: SW
ADA ID: B68EDDB409B8	Ramp Type: Perp	Initial Pass/Fail: Fail	Overall Compliance: No
Severity Score: 8.75			
Codes/Mitigation Info/Possible Solution		Field Measurements/Component Compliance

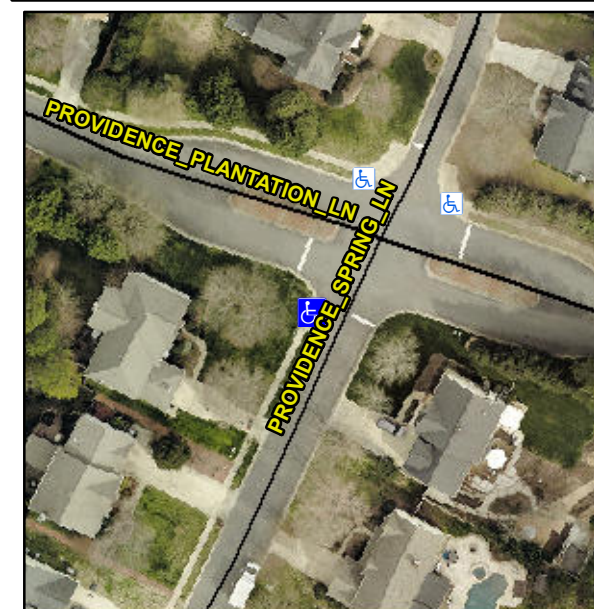
**Not Found, R304.5.1**

Compliance	Description	Data	Compliance	Description	Data
N/A	Ramp Length (in)	51.0	Yes	Ramp Slope (%)	5.8
No	Ramp Width (in)	44.0	Yes	Ramp XSlope (%)	1.5
N/A	Flare Type LT	N/A	N/A	Flare Type RT	N/A
N/A	Flare Slope LT (%)	N/A	N/A	Flare Slope RT (%)	N/A
N/A	Flare Traversable LT?	N/A	N/A	Flare Traversable RT?	N/A
N/A	Landing Length (in)	N/A	N/A	DWS Provided?	N/A
N/A	Landing Width (in)	N/A	N/A	DWS Contrast?	N/A
N/A	Landing Slope (%)	N/A	N/A	DWS Length (in)	N/A
N/A	Landing X Slope (%)	N/A	N/A	DWS Full Width?	N/A
N/A	Landing Curb? (Y/N)	N/A	N/A	DWS Offset (in)	N/A
N/A	Shared Landing?	N/A			
N/A	Gutter Ponding?	N/A	N/A	Gutter Slope (%)	N/A
N/A	Gutter Lip Ht (in)	N/A	N/A	Gutter X Slope (%)	N/A
N/A	Painted X Walk1?	No	N/A	Painted X Walk2?	N/A
	X Walk 1 Direction	To NE		X Walk 2 Direction	N/A
N/A	X Walk 1 Width (in)	N/A	N/A	X Walk 2 Width (in)	N/A
	X Walk 1 Slope (%)	2.8		X Walk 2 Slope (%)	N/A
	X Walk 1 X Slope (%)	1.4		X Walk 2 X Slope (%)	N/A

N/A	Ramp inside XWalk1?	N/A	N/A	Ramp inside XWalk2?	N/A
	Road Slope (%)	N/A	N/A	Clear Space?	N/A
	Road X Slope (%)	N/A	N/A	Clear Space to XWalk (in)	N/A
N/A	Any Obstructions?	N/A	N/A	Storm Grate/Utility Hazard?	N/A
	Obstruction Type			Storm Grate/Utility Type	
		N/A			N/A
			Yes	Surface Condition? (G/P)	Good

**Remove & Replace Entire Ramp.**

Total Cost: \$ 1850.00
