# Access Compliance Report

## Public Rights-of-Way

| Intersection ID: 49946 | Main Street: OPEN_BOOK_LN | Cross Street: KUYKENDALL_RD | Location: W |
| ADA ID: B6951921F2BC | Ramp Type: BlendTrans1 | Initial Pass/Fail: Pass | Overall Compliance: No |

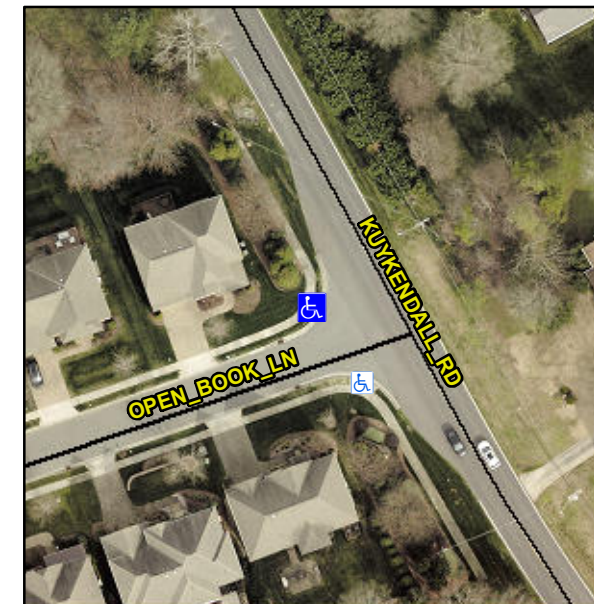
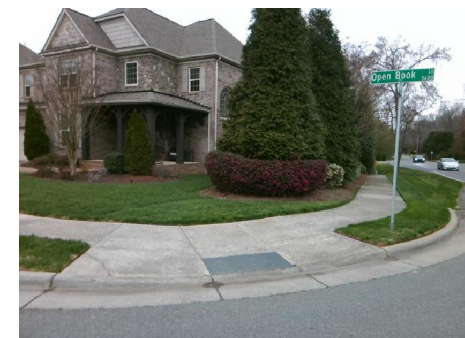
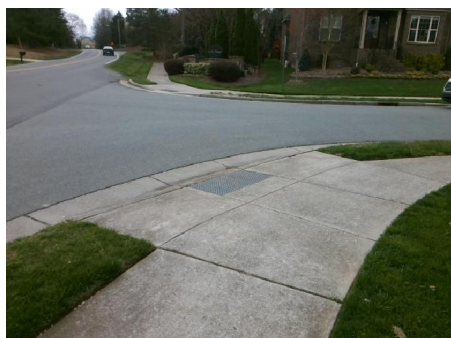
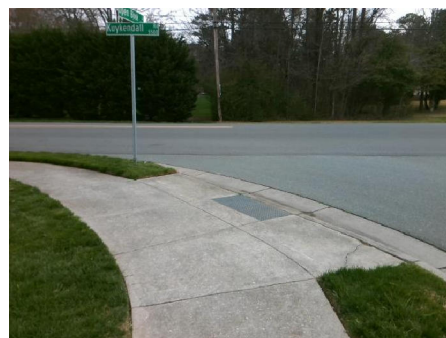
**Not Found, R304.2.2-Perp, R304.3.2-Para, R304.5.4**

| Compliance | Description | Data | Compliance | Description | Data |
|---|---|---|---|---|---|
| No | Landing Slope (%) | 2.6 | Yes | DWS Length (in) | 24.5 |
| Yes | Gutter Ponding? | No | No | Gutter Slope (%) | 6.1 |
| | | | No | Curb Slope (%) | 23.5 |

**Remove & Replace Curb Ramp With Two New Directional Ramps or Equivalent. Remove & Replace Gutter.**
