Access Compliance Report

Public Rights-of-Way

(Curb Ramps)

Intersection ID: 44925	Main Street: TWIN_BROOK_DR	Cross Street: MINTVALE_DR	Location: SE
ADA ID: B6A0CF43954B	Ramp Type: Perp	Initial Pass/Fail: Fail	Overall Compliance: No
Severity Score: 33.75			
Codes/Mitigation Info/Possible Solution		Field Measurements/Component Compliance

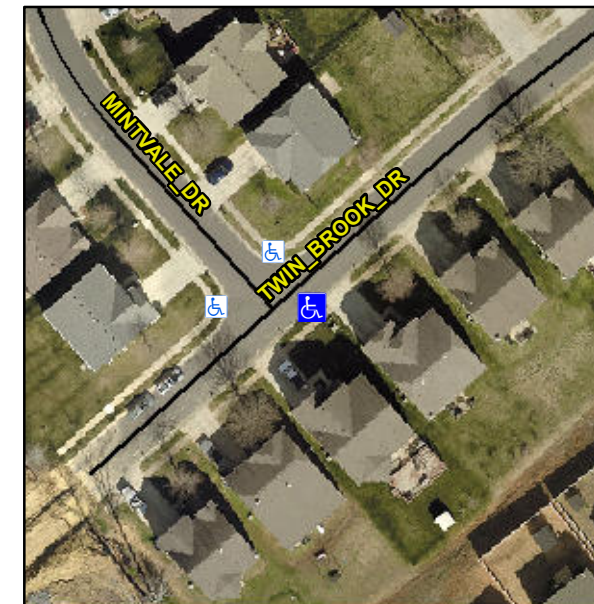
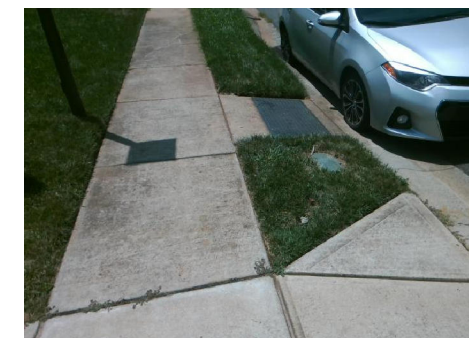
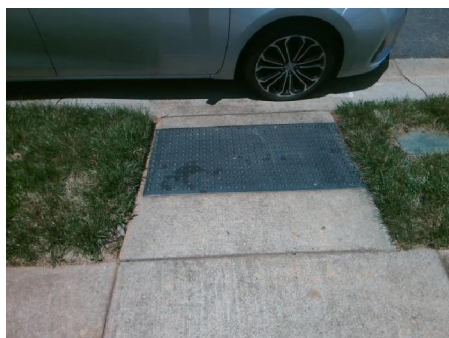
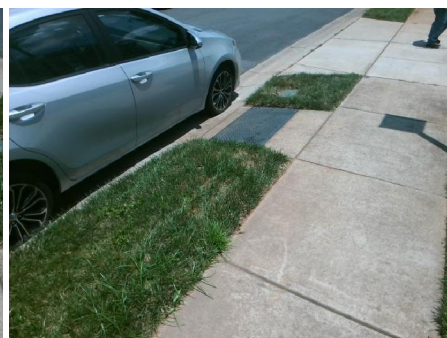
Not Found, R304.5.1, R304.2.2

Compliance	Description	Data	Compliance	Description	Data
N/A	Ramp Length (in)	47.0	No	Ramp Slope (%)	15.5
No	Ramp Width (in)	47.5	Yes	Ramp XSlope (%)	0.2
N/A	Flare Type LT	N/A	N/A	Flare Type RT	N/A
N/A	Flare Slope LT (%)	N/A	N/A	Flare Slope RT (%)	N/A
N/A	Flare Traversable LT?	N/A	N/A	Flare Traversable RT?	N/A
N/A	Landing Length (in)	N/A	N/A	DWS Provided?	N/A
N/A	Landing Width (in)	N/A	N/A	DWS Contrast?	N/A
N/A	Landing Slope (%)	N/A	N/A	DWS Length (in)	N/A
N/A	Landing X Slope (%)	N/A	N/A	DWS Full Width?	N/A
N/A	Landing Curb? (Y/N)	N/A	N/A	DWS Offset (in)	N/A
N/A	Shared Landing?	N/A			
N/A	Gutter Ponding?	N/A	N/A	Gutter Slope (%)	N/A
N/A	Gutter Lip Ht (in)	N/A	N/A	Gutter X Slope (%)	N/A
N/A	Painted X Walk1?	No	N/A	Painted X Walk2?	N/A
	X Walk 1 Direction	To NW		X Walk 2 Direction	N/A
N/A	X Walk 1 Width (in)	N/A	N/A	X Walk 2 Width (in)	N/A
	X Walk 1 Slope (%)	3.6		X Walk 2 Slope (%)	N/A
	X Walk 1 X Slope (%)	0.7		X Walk 2 X Slope (%)	N/A

N/A	Ramp inside XWalk1?	N/A	N/A	Ramp inside XWalk2?	N/A
	Road Slope (%)	N/A	N/A	Clear Space?	N/A
	Road X Slope (%)	N/A	N/A	Clear Space to XWalk (in)	N/A
N/A	Any Obstructions?	N/A	N/A	Storm Grate/Utility Hazard?	N/A
	Obstruction Type			Storm Grate/Utility Type	
		N/A			N/A
			Yes	Surface Condition? (G/P)	Good

Possible Solutions:

Remove & Replace Entire Ramp.
