Access Compliance Report

Public Rights-of-Way

(Curb Ramps)

Intersection ID: 15548	Main Street: HEMLOCK_ST	Cross Street: SCOTT_AV	Location: N
ADA ID: B6A384C8C8D2	Ramp Type: Directional1	Initial Pass/Fail: Fail	Overall Compliance: No
			Severity Score: 46.25

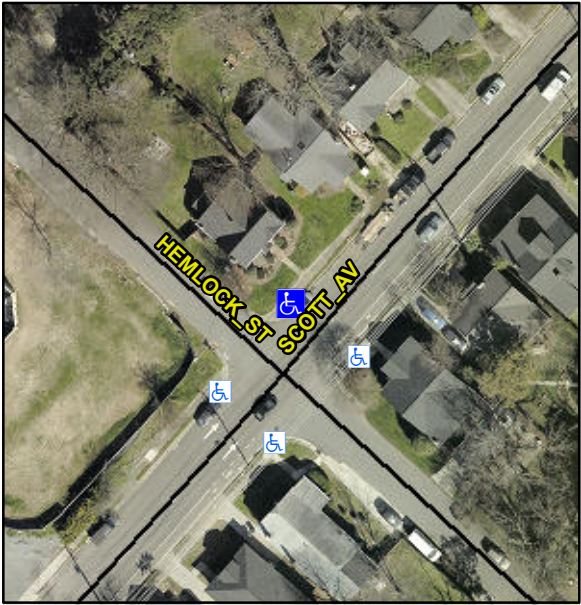
Possible Solutions:		Compliance	Description	Data	
	Remove & Replace Entire Ramp.		N/A	Ramp Length (in)	61.0	N/A
			No	Ramp Width (in)	43.0	N/A
			No	Ramp Slope (%)	12.0	N/A
			No	Ramp XSlope (%)	6.0	N/A
			N/A	Flare Type LT	N/A	N/A
			N/A	Flare Slope LT (%)	N/A	N/A
			N/A	Flare Traversable LT?	N/A	N/A
			N/A	Landing Length (in)	0.0	N/A
			N/A	Landing Width (in)	0.0	N/A
			N/A	Landing Slope (%)	0.0	N/A
			N/A	Landing X Slope (%)	0.0	N/A
			N/A	Landing Curb? (Y/N)	N/A	N/A
			N/A	Shared Landing?	N/A	N/A
			N/A	Gutter Ponding?	0.0	N/A
			N/A	Gutter Lip Ht (in)	0.0	N/A
			N/A	Painted X Walk1?	No	N/A
				X Walk 1 Direction	To SW	N/A
				X Walk 1 Width (in)	N/A	N/A
				X Walk 1 Slope (%)	2.8	N/A
				X Walk 1 X Slope (%)	5.3	N/A
<p>Surveyor Notes:</p> <p>N/A</p>			N/A	Ramp inside XWalk1?	N/A	N/A
			N/A	Any Obstructions?	N/A	N/A
<p>PROW/ADA:</p> <p>R304.5.1, R304.2.2, R304.5.3</p>				Obstruction Type

Yes	Surface Condition? (G/P)		Good
			N/A	Curb Slope (%)		11.0
