Access Compliance Report

Public Rights-of-Way

(Curb Ramps)

Intersection ID: 12972	Main Street: HAMORTON_PL	Cross Street: THOMAS_AV	Location: NW
ADA ID: B6A9929C3A8C	Ramp Type: PerpDiag	Initial Pass/Fail: Fail	Overall Compliance: No
		Severity Score: 12.5

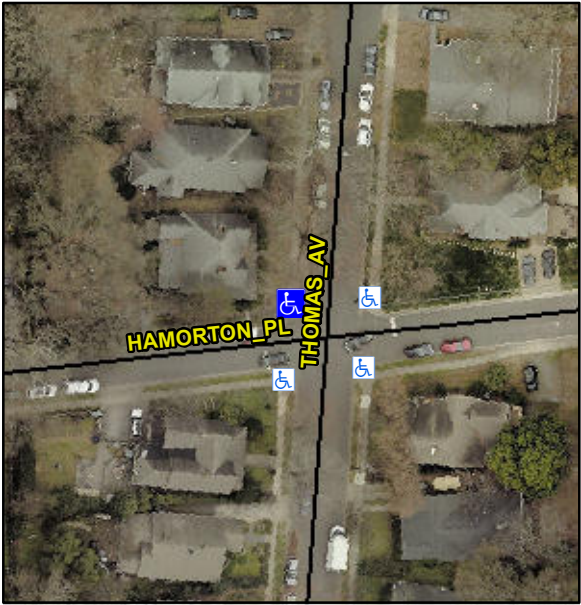
Possible Solutions:		Compliance	Description	Data
	Remove & Replace Curb Ramp With Two New Directional Ramps or Equivalent.		Yes	Ramp Length (in)	57.0
			N/A	Ramp Width (in)	48.0
			N/A	Flare Type LT	N/A
			N/A	Flare Slope LT (%)	N/A
			N/A	Flare Traversable LT?	N/A
			N/A	Flare Type RT	N/A
			N/A	Flare Slope RT (%)	N/A
			N/A	Flare Traversable RT?	N/A
			N/A	DWS Provided?	N/A
<p>Surveyor Notes:</p> <p>N/A</p>			N/A	DWS Contrast?	N/A
			N/A	DWS Length (in)	N/A
			N/A	DWS Full Width?	N/A
			N/A	DWS Offset (in)	N/A
			N/A	Gutter Ponding?	N/A
			N/A	Gutter X Slope (%)	N/A
			N/A	Painted X Walk1?	No
			N/A	X Walk 1 Direction	To S
			N/A	X Walk 2 Direction	To E
			N/A	X Walk 2 Width (in)	N/A
<p>PROW/ADA:</p> <p>Not Found, R304.5.3</p>			N/A	X Walk 2 Slope (%)	5.1
			N/A	X Walk 2 X Slope (%)	0.2
			N/A	Ramp inside XWalk1?	N/A
			N/A	Ramp inside XWalk2?	N/A

N/A	Road Slope (%)	0.0
			N/A	Road X Slope (%)	2.2
			N/A	Clear Space?	N/A
			N/A	Clear Space to XWalk (in)	N/A
			N/A	Storm Grate/Utility Hazard?	N/A
			N/A	Storm Grate/Utility Type	N/A
<p>Total Cost:</p> <p>\$ 3200.00</p>			N/A	Surface Condition? (G/P)	Good
			N/A
