# Access Compliance Report

## Public Rights-of-Way

### (Curb Ramps)

| Intersection ID: 15205 | Main Street: CHEROKEE_RD | Cross Street: FENTON_PL | Location: S |

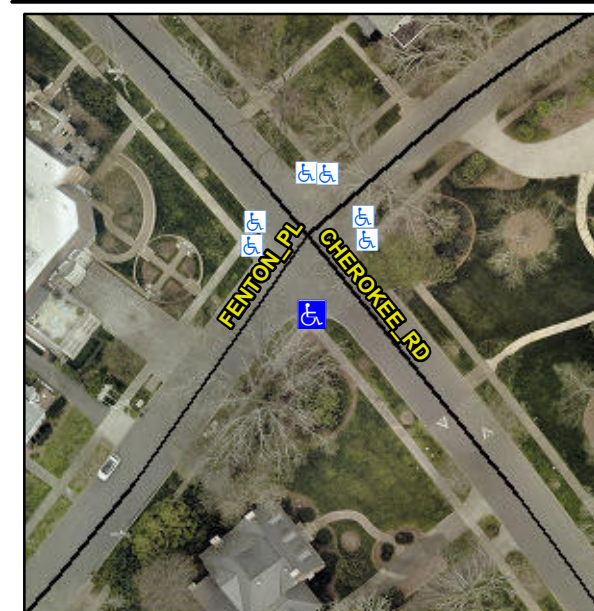
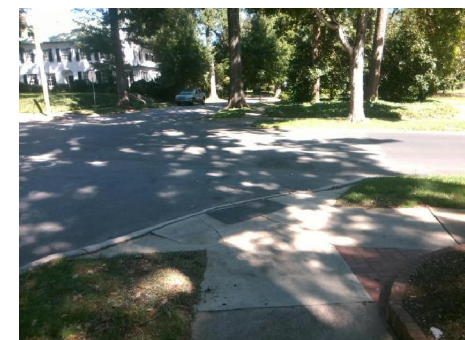
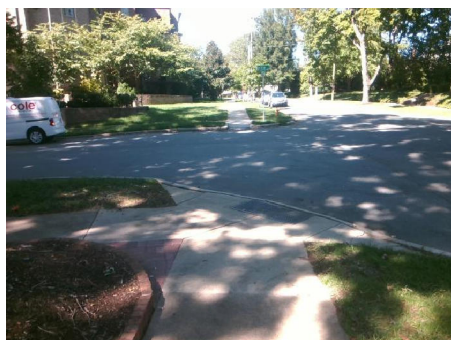
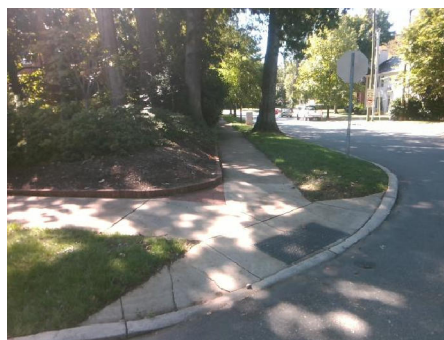
| ADA ID: B6B0EC0D649C | Ramp Type: BlendTrans2 | Initial Pass/Fail: Pass | Overall Compliance: No |

**Not Found, R304.5.3, R305.1.4, R305.2**

| Compliance | Description | Data | Compliance | Description | Data |
|---|---|---|---|---|---|
| Yes | Ramp Width (in) | 94.0 | No | BlendTrans XSlope (%) | 3.3 |
| N/A | Landing X Slope (%) | N/A | No | DWS Full Width? | No |
| N/A | Landing Curb? (Y/N) | No | No | DWS Offset (in) | 3.0 |
| Yes | Gutter Lip Ht (in) | 0.0 | No | Gutter X Slope (%) | 3.4 |
| | | | No | Curb Slope (%) | 15.6 |

**Remove & Replace Curb Ramp With Two New Directional Ramps or Equivalent. Remove & Replace Gutter.**

Total Cost: \$ 3950.00
