Access Compliance Report

Public Rights-of-Way

(Curb Ramps)

Intersection ID: 47571	Main Street: SEDGEBURN_DR	Cross Street: HERMSLEY_RD	Location: SE
ADA ID: B6B27917615D	Ramp Type: PerpDiag	Initial Pass/Fail: Fail	Overall Compliance: No
Severity Score: 10			
Codes/Mitigation Info/Possible Solution		Field Measurements/Component Compliance

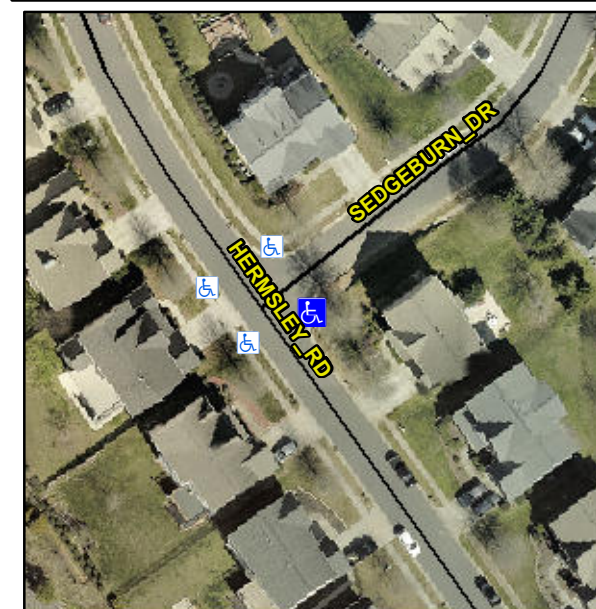
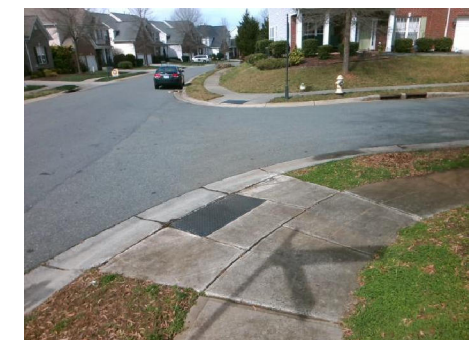
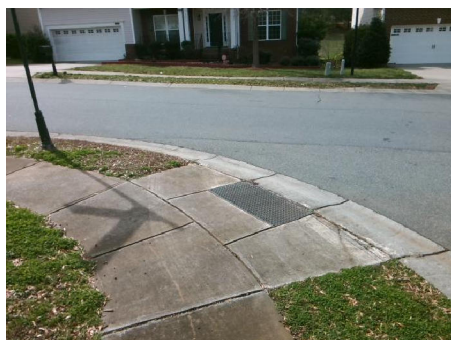
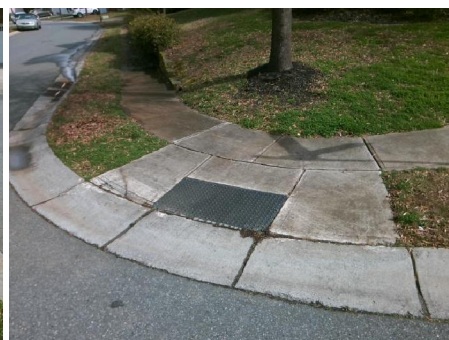
Not Found, R304.5.1, R304.5.3

Compliance	Description	Data	Compliance	Description	Data
N/A	Ramp Length (in)	48.0	Yes	Ramp Slope (%)	6.3
No	Ramp Width (in)	44.0	No	Ramp XSlope (%)	3.0
N/A	Flare Type LT	N/A	N/A	Flare Type RT	N/A
N/A	Flare Slope LT (%)	N/A	N/A	Flare Slope RT (%)	N/A
N/A	Flare Traversable LT?	N/A	N/A	Flare Traversable RT?	N/A
N/A	Landing Length (in)	N/A	N/A	DWS Provided?	N/A
N/A	Landing Width (in)	N/A	N/A	DWS Contrast?	N/A
N/A	Landing Slope (%)	N/A	N/A	DWS Length (in)	N/A
N/A	Landing X Slope (%)	N/A	N/A	DWS Full Width?	N/A
N/A	Landing Curb? (Y/N)	N/A	N/A	DWS Offset (in)	N/A
N/A	Shared Landing?	N/A			
N/A	Gutter Ponding?	N/A	N/A	Gutter Slope (%)	N/A
N/A	Gutter Lip Ht (in)	N/A	N/A	Gutter X Slope (%)	N/A
N/A	Painted X Walk1?	No	N/A	Painted X Walk2?	No
	X Walk 1 Direction	To NW		X Walk 2 Direction	To SW
N/A	X Walk 1 Width (in)	N/A	N/A	X Walk 2 Width (in)	N/A
	X Walk 1 Slope (%)	0.9		X Walk 2 Slope (%)	2.3
	X Walk 1 X Slope (%)	0.6		X Walk 2 X Slope (%)	3.3

N/A	Ramp inside XWalk1?	N/A	N/A	Ramp inside XWalk2?	N/A
	Road Slope (%)	2.7	N/A	Clear Space?	N/A
	Road X Slope (%)	0.3	N/A	Clear Space to XWalk (in)	N/A
N/A	Any Obstructions?	N/A	N/A	Storm Grate/Utility Hazard?	N/A
	Obstruction Type			Storm Grate/Utility Type	
		N/A			N/A
		Yes		Surface Condition? (G/P)	Good

Remove & Replace Curb Ramp With Two New Directional Ramps or Equivalent.
