Access Compliance Report

Public Rights-of-Way

(Curb Ramps)

Intersection ID: N/A	Main Street: HOSTA_DR	Cross Street: N/A	Location: NE
ADA ID: B6B3A06F3024	Ramp Type: PerpDiag	Initial Pass/Fail: Fail	Overall Compliance: No
Codes/Mitigation Info/Possible Solution		Field Measurements/Component Compliance

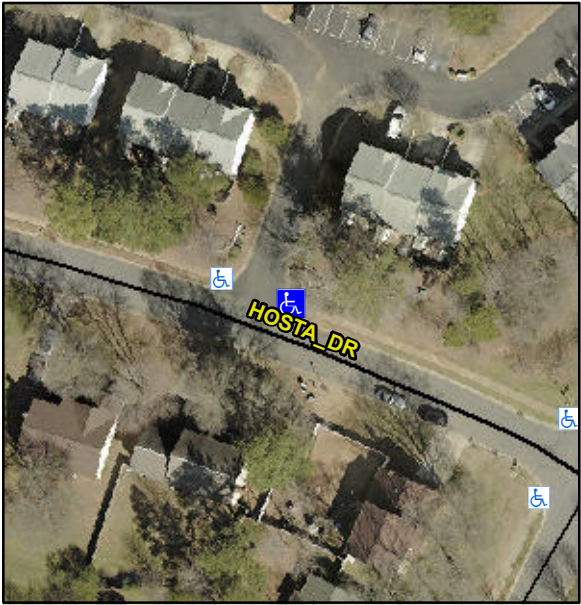
Possible Solutions:						
	Remove & Replace Curb Ramp With Two New Directional Ramps or Equivalent.	N/A	Ramp Length (in)	26.0	Yes	Ramp Slope (%)	6.3
		Yes	Ramp Width (in)	48.0	No	Ramp XSlope (%)	6.0
		N/A	Flare Type LT	N/A	N/A	Flare Type RT	N/A
		N/A	Flare Slope LT (%)	N/A	N/A	Flare Slope RT (%)	N/A
		N/A	Flare Traversable LT?	N/A	N/A	Flare Traversable RT?	N/A
		N/A	Landing Length (in)	N/A	N/A	DWS Provided?	N/A
		N/A	Landing Width (in)	N/A	N/A	DWS Contrast?	N/A
		N/A	Landing Slope (%)	N/A	N/A	DWS Length (in)	N/A
		N/A	Landing X Slope (%)	N/A	N/A	DWS Full Width?	N/A
		N/A	Landing Curb? (Y/N)	N/A	N/A	DWS Offset (in)	N/A
		N/A	Shared Landing?	N/A			
		N/A	Gutter Ponding?	N/A	N/A	Gutter Slope (%)	N/A
		N/A	Gutter Lip Ht (in)	N/A	N/A	Gutter X Slope (%)	N/A
		N/A	Painted X Walk1?	No	N/A	Painted X Walk2?	No
			X Walk 1 Direction	To W		X Walk 2 Direction	To S
		N/A	X Walk 1 Width (in)	N/A	N/A	X Walk 2 Width (in)	N/A

X Walk 1 Slope (%)	5.5		X Walk 2 Slope (%)	3.1
			X Walk 1 X Slope (%)	3.1		X Walk 2 X Slope (%)	6.5
		N/A	Ramp inside XWalk1?	N/A	N/A	Ramp inside XWalk2?	N/A
<p>Surveyor Notes:</p> <p>N/A</p> <p>PROW/ADA:</p> <p>Not Found, R304.5.3</p>			Road Slope (%)	5.1	N/A	Clear Space?	N/A
			Road X Slope (%)	3.8	N/A	Clear Space to XWalk (in)	N/A
		N/A	Any Obstructions?	N/A	N/A	Storm Grate/Utility Hazard?	N/A
			Obstruction Type			Storm Grate/Utility Type	
					N/A		N/A
					Yes	Surface Condition? (G/P)	Good
Total Cost:		\$	3200.00
