Access Compliance Report

Public Rights-of-Way

(Curb Ramps)

Intersection ID: N/A	Main Street: CLEMS_BRANCH_DR	Cross Street: N/A	Location: W
ADA ID: B6B8982953D1	Ramp Type: Perp	Initial Pass/Fail: Fail	Overall Compliance: No
		Severity Score: 10

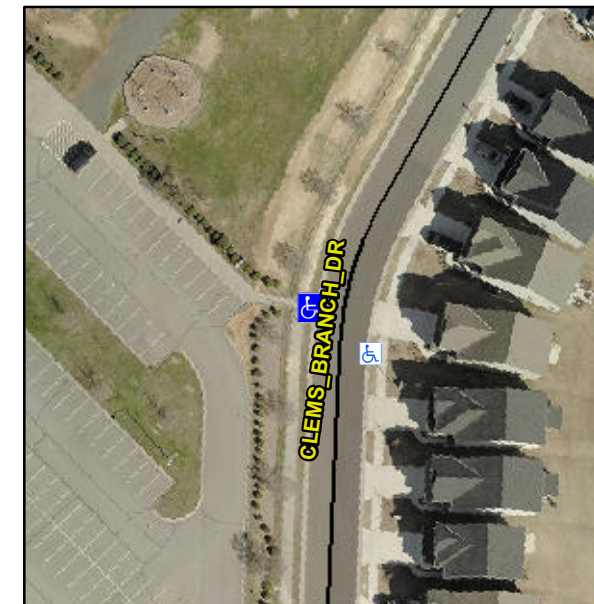
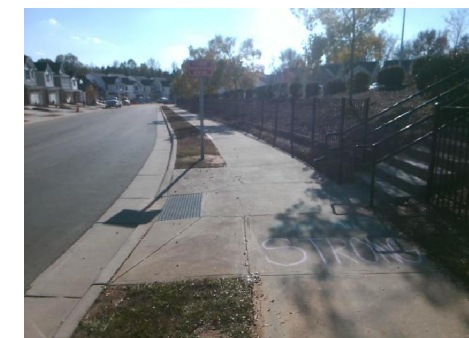
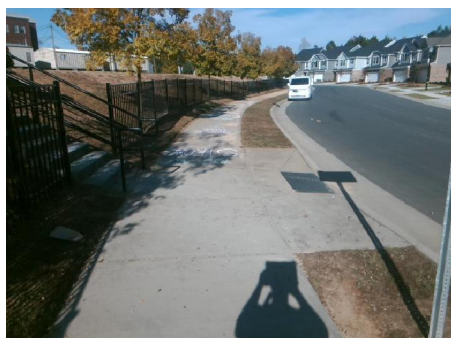
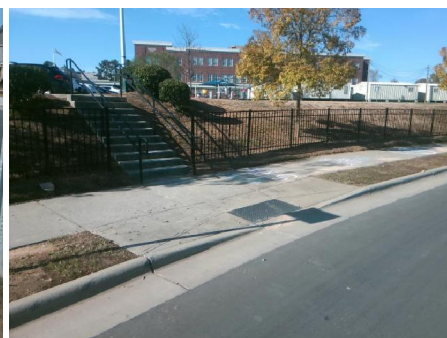
Not Found, R304.5.1, R304.5.3

Compliance	Description	Data	Compliance	Description	Data
N/A	Ramp Length (in)	69.0	Yes	Ramp Slope (%)	6.9
No	Ramp Width (in)	47.0	No	Ramp XSlope (%)	3.4
N/A	Flare Type LT	N/A	N/A	Flare Type RT	N/A
N/A	Flare Slope LT (%)	N/A	N/A	Flare Slope RT (%)	N/A
N/A	Flare Traversable LT?	N/A	N/A	Flare Traversable RT?	N/A
N/A	Landing Length (in)	N/A	N/A	DWS Provided?	N/A
N/A	Landing Width (in)	N/A	N/A	DWS Contrast?	N/A
N/A	Landing Slope (%)	N/A	N/A	DWS Length (in)	N/A
N/A	Landing X Slope (%)	N/A	N/A	DWS Full Width?	N/A
N/A	Landing Curb? (Y/N)	N/A	N/A	DWS Offset (in)	N/A
N/A	Shared Landing?	N/A			
N/A	Gutter Ponding?	N/A	N/A	Gutter Slope (%)	N/A
N/A	Gutter Lip Ht (in)	N/A	N/A	Gutter X Slope (%)	N/A
N/A	Painted X Walk1?	No	N/A	Painted X Walk2?	N/A
	X Walk 1 Direction	To SE		X Walk 2 Direction	N/A
N/A	X Walk 1 Width (in)	N/A	N/A	X Walk 2 Width (in)	N/A
	X Walk 1 Slope (%)	3.5		X Walk 2 Slope (%)	N/A
	X Walk 1 X Slope (%)	1.9		X Walk 2 X Slope (%)	N/A

N/A	Ramp inside XWalk1?	N/A	N/A	Ramp inside XWalk2?	N/A
	Road Slope (%)	N/A	N/A	Clear Space?	N/A
	Road X Slope (%)	N/A	N/A	Clear Space to XWalk (in)	N/A
N/A	Any Obstructions?	N/A	N/A	Storm Grate/Utility Hazard?	N/A
	Obstruction Type			Storm Grate/Utility Type	
		N/A			N/A
			Yes	Surface Condition? (G/P)	Good

Possible Solutions:

Remove & Replace Entire Ramp.
