Access Compliance Report

Public Rights-of-Way

(Curb Ramps)

Intersection ID: 19296	Main Street: MEADOWOOD_LN	Cross Street: PROVIDENCE_RD	Location: NE
ADA ID: B6B8E1EABBB7	Ramp Type: BlendTrans2	Initial Pass/Fail: Fail	Overall Compliance: No
Severity Score: 10			
Codes/Mitigation Info/Possible Solution		Field Measurements/Component Compliance

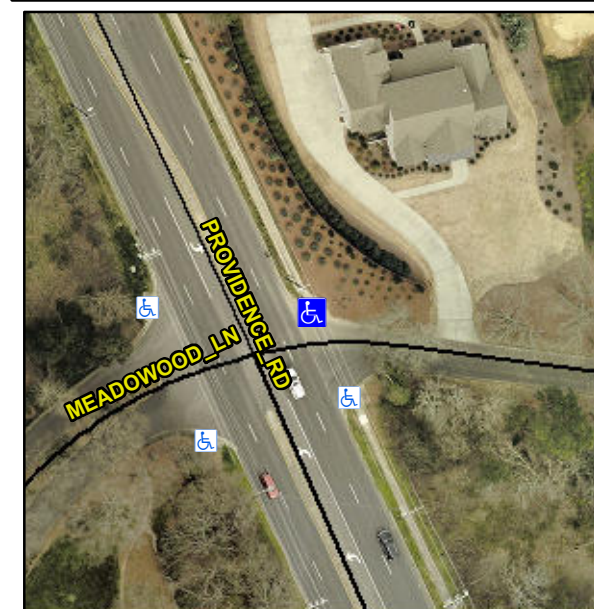
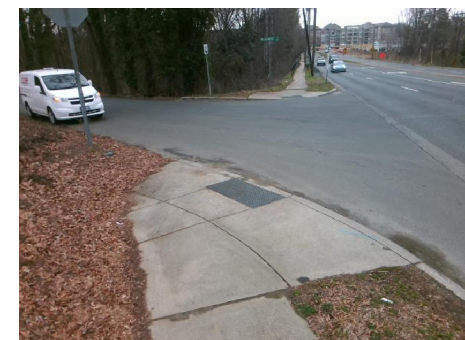
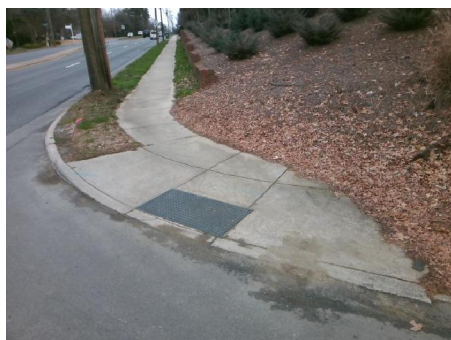
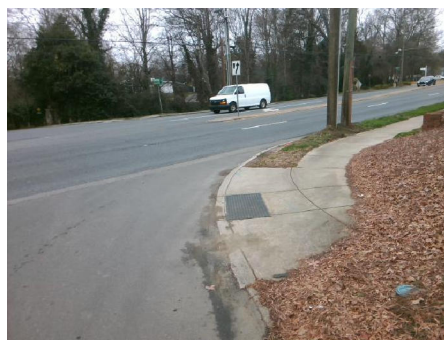
R304.5.1, R304.5.3

Compliance	Description	Data	Compliance	Description	Data
N/A	Ramp Length (in)	96.0	Yes	BlendTrans Slope (%)	3.6
No	Ramp Width (in)	40.0	No	BlendTrans XSlope (%)	4.2
N/A	Flare Type LT	N/A	N/A	Flare Type RT	N/A
N/A	Flare Slope LT (%)	N/A	N/A	Flare Slope RT (%)	N/A
N/A	Flare Traversable LT?	N/A	N/A	Flare Traversable RT?	N/A
N/A	Landing Length (in)	N/A	N/A	DWS Provided?	N/A
N/A	Landing Width (in)	N/A	N/A	DWS Contrast?	N/A
N/A	Landing Slope (%)	N/A	N/A	DWS Length (in)	N/A
N/A	Landing X Slope (%)	N/A	N/A	DWS Full Width?	N/A
N/A	Landing Curb? (Y/N)	N/A	N/A	DWS Offset (in)	N/A
N/A	Shared Landing?	N/A			
N/A	Gutter Ponding?	N/A	N/A	Gutter Slope (%)	N/A
N/A	Gutter Lip Ht (in)	N/A	N/A	Gutter X Slope (%)	N/A
N/A	Painted X Walk1?	No	N/A	Painted X Walk2?	No
	X Walk 1 Direction	To W		X Walk 2 Direction	To SE
	X Walk 1 Width (in)	N/A		X Walk 2 Width (in)	N/A
	X Walk 1 Slope (%)	2.3		X Walk 2 Slope (%)	0.3
	X Walk 1 X Slope (%)	0.3		X Walk 2 X Slope (%)	1.1

N/A	Ramp inside XWalk1?	N/A	N/A	Ramp inside XWalk2?	N/A
	Road Slope (%)	1.0		Clear Space?	N/A
	Road X Slope (%)	1.3	N/A	Clear Space to XWalk (in)	N/A
N/A	Any Obstructions?	N/A	N/A	Storm Grate/Utility Hazard?	N/A
	Obstruction Type			Storm Grate/Utility Type	
		N/A			N/A
			Yes	Surface Condition? (G/P)	Good
			N/A	Curb Slope (%)	1.7

Remove & Replace Curb Ramp With Two New Directional Ramps or Equivalent.
