Access Compliance Report

Public Rights-of-Way

(Curb Ramps)

Intersection ID: 30444	Main Street: NANNYBERRY_LN	Cross Street: TABCAT_CT	Location: SE
ADA ID: B6BFE7F0698B	Ramp Type: PerpDiag	Initial Pass/Fail: Fail	Overall Compliance: No
Severity Score: 21.25			
Codes/Mitigation Info/Possible Solution		Field Measurements/Component Compliance

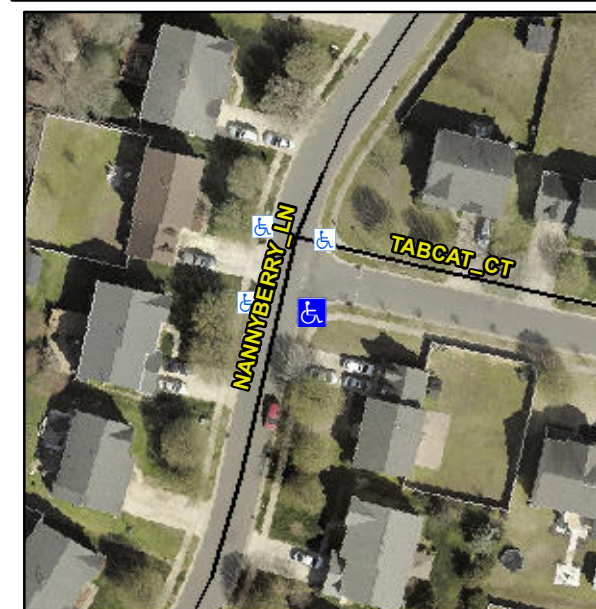
R304.5.1, R304.5.3

Compliance	Description	Data	Compliance	Description	Data
N/A	Ramp Length (in)	47.0	Yes	Ramp Slope (%)	5.6
No	Ramp Width (in)	45.5	No	Ramp XSlope (%)	5.1
N/A	Flare Type LT	N/A	N/A	Flare Type RT	N/A
N/A	Flare Slope LT (%)	N/A	N/A	Flare Slope RT (%)	N/A
N/A	Flare Traversable LT?	N/A	N/A	Flare Traversable RT?	N/A
N/A	Landing Length (in)	N/A	N/A	DWS Provided?	N/A
N/A	Landing Width (in)	N/A	N/A	DWS Contrast?	N/A
N/A	Landing Slope (%)	N/A	N/A	DWS Length (in)	N/A
N/A	Landing X Slope (%)	N/A	N/A	DWS Full Width?	N/A
N/A	Landing Curb? (Y/N)	N/A	N/A	DWS Offset (in)	N/A
N/A	Shared Landing?	N/A			
N/A	Gutter Ponding?	N/A	N/A	Gutter Slope (%)	N/A
N/A	Gutter Lip Ht (in)	N/A	N/A	Gutter X Slope (%)	N/A
N/A	Painted X Walk1?	No	N/A	Painted X Walk2?	No
	X Walk 1 Direction	To NE		X Walk 2 Direction	To NW
N/A	X Walk 1 Width (in)	N/A	N/A	X Walk 2 Width (in)	N/A
	X Walk 1 Slope (%)	0.9		X Walk 2 Slope (%)	0.5
	X Walk 1 X Slope (%)	0.3		X Walk 2 X Slope (%)	1.4

N/A	Ramp inside XWalk1?	N/A	N/A	Ramp inside XWalk2?	N/A
	Road Slope (%)	1.3	N/A	Clear Space?	N/A
	Road X Slope (%)	0.4	N/A	Clear Space to XWalk (in)	N/A
N/A	Any Obstructions?	N/A	N/A	Storm Grate/Utility Hazard?	N/A
	Obstruction Type			Storm Grate/Utility Type	
		N/A			N/A
			Yes	Surface Condition? (G/P)	Good

Remove & Replace Curb Ramp With Two New Directional Ramps or Equivalent.
