Access Compliance Report

Public Rights-of-Way

(Curb Ramps)

Intersection ID: 27486	Main Street: DOWINGTON_DR	Cross Street: HOLLYBUSH_LN	Location: SE
ADA ID: B6BFEC7C279D	Ramp Type: Perp	Initial Pass/Fail: Fail	Overall Compliance: No
Severity Score: 26.25			
Codes/Mitigation Info/Possible Solution		Field Measurements/Component Compliance

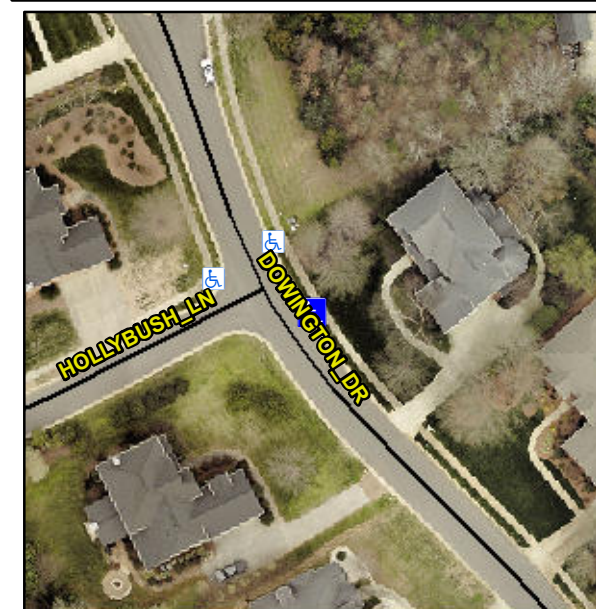
Not Found, R304.2.2, R304.5.3

Compliance	Description	Data	Compliance	Description	Data
N/A	Ramp Length (in)	48.0	No	Ramp Slope (%)	14.4
Yes	Ramp Width (in)	48.0	No	Ramp XSlope (%)	4.4
N/A	Flare Type LT	N/A	N/A	Flare Type RT	N/A
N/A	Flare Slope LT (%)	N/A	N/A	Flare Slope RT (%)	N/A
N/A	Flare Traversable LT?	N/A	N/A	Flare Traversable RT?	N/A
N/A	Landing Length (in)	N/A	N/A	DWS Provided?	N/A
N/A	Landing Width (in)	N/A	N/A	DWS Contrast?	N/A
N/A	Landing Slope (%)	N/A	N/A	DWS Length (in)	N/A
N/A	Landing X Slope (%)	N/A	N/A	DWS Full Width?	N/A
N/A	Landing Curb? (Y/N)	N/A	N/A	DWS Offset (in)	N/A
N/A	Shared Landing?	N/A			
N/A	Gutter Ponding?	N/A	N/A	Gutter Slope (%)	N/A
N/A	Gutter Lip Ht (in)	N/A	N/A	Gutter X Slope (%)	N/A
N/A	Painted X Walk1?	No	N/A	Painted X Walk2?	N/A
	X Walk 1 Direction	To W		X Walk 2 Direction	N/A
N/A	X Walk 1 Width (in)	N/A	N/A	X Walk 2 Width (in)	N/A
	X Walk 1 Slope (%)	2.5		X Walk 2 Slope (%)	N/A
	X Walk 1 X Slope (%)	1.5		X Walk 2 X Slope (%)	N/A

N/A	Ramp inside XWalk1?	N/A	N/A	Ramp inside XWalk2?	N/A
	Road Slope (%)	N/A	N/A	Clear Space?	N/A
	Road X Slope (%)	N/A	N/A	Clear Space to XWalk (in)	N/A
N/A	Any Obstructions?	N/A	N/A	Storm Grate/Utility Hazard?	N/A
	Obstruction Type			Storm Grate/Utility Type	
		N/A			N/A
		Yes		Surface Condition? (G/P)	Good

Possible Solutions:

Remove & Replace Entire Ramp.

Total Cost: \$ 1850.00
