# Access Compliance Report

## Public Rights-of-Way

### (Curb Ramps)

Intersection ID: 15242	Main Street: E_INDEPENDENCE_BV	Cross Street: N_WENDOVER_RD_RA	Location: NW
ADA ID: B6C5B248D32D	Ramp Type: BlendTrans1	Initial Pass/Fail: Fail	Overall Compliance: No
		Severity Score: 17.5

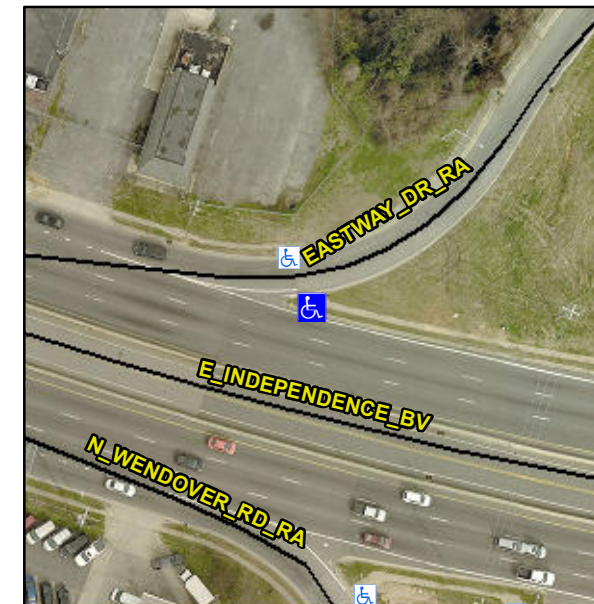
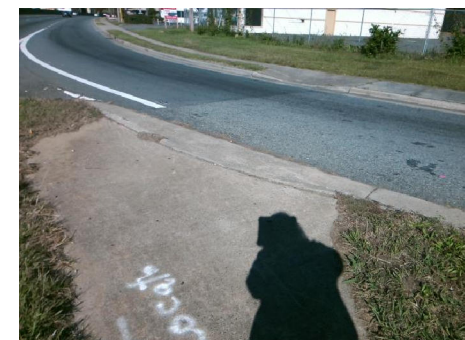
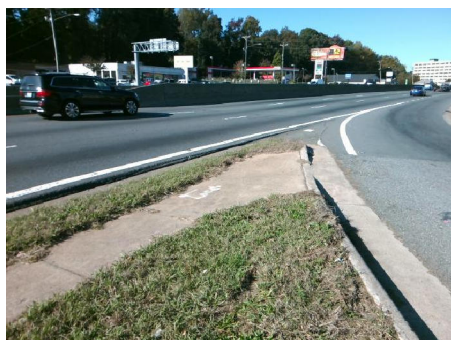
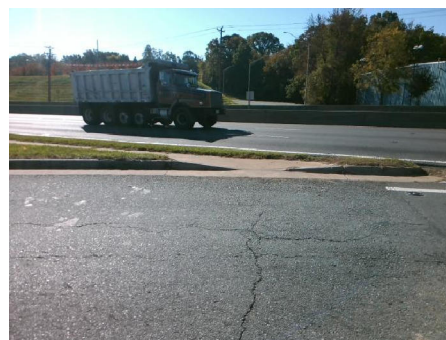
**Not Found, R304.5.1**

Compliance	Description	Data	Compliance	Description	Data
N/A	Ramp Length (in)	65.0	Yes	BlendTrans Slope (%)	3.2
No	Ramp Width (in)	34.5	Yes	BlendTrans XSlope (%)	1.9
N/A	Flare Type LT	N/A	N/A	Flare Type RT	N/A
N/A	Flare Slope LT (%)	N/A	N/A	Flare Slope RT (%)	N/A
N/A	Flare Traversable LT?	N/A	N/A	Flare Traversable RT?	N/A
N/A	Landing Length (in)	N/A	N/A	DWS Provided?	N/A
N/A	Landing Width (in)	N/A	N/A	DWS Contrast?	N/A
N/A	Landing Slope (%)	N/A	N/A	DWS Length (in)	N/A
N/A	Landing X Slope (%)	N/A	N/A	DWS Full Width?	N/A
N/A	Landing Curb? (Y/N)	N/A	N/A	DWS Offset (in)	N/A
N/A	Shared Landing?	N/A			
N/A	Gutter Ponding?	N/A	N/A	Gutter Slope (%)	N/A
N/A	Gutter Lip Ht (in)	0.5	N/A	Gutter X Slope (%)	N/A
N/A	Painted X Walk1?	No	N/A	Painted X Walk2?	N/A
	X Walk 1 Direction	To N		X Walk 2 Direction	N/A
	X Walk 1 Width (in)	N/A		X Walk 2 Width (in)	N/A
	X Walk 1 Slope (%)	3.8		X Walk 2 Slope (%)	N/A
	X Walk 1 X Slope (%)	1.9		X Walk 2 X Slope (%)	N/A

N/A	Ramp inside XWalk1?	N/A	N/A	Ramp inside XWalk2?	N/A
	Road Slope (%)	1.9		Clear Space?	N/A
	Road X Slope (%)	3.8	N/A	Clear Space to XWalk (in)	N/A
N/A	Any Obstructions?	N/A	N/A	Storm Grate/Utility Hazard?	N/A
	Obstruction Type			Storm Grate/Utility Type	
		N/A			N/A
			Yes	Surface Condition? (G/P)	Good
			No	Curb Slope (%)	18.3

**Remove & Replace Curb Ramp With Two New Directional Ramps or Equivalent.**

Total Cost: \$ 3200.00
