# Access Compliance Report

## Public Rights-of-Way

### (Curb Ramps)

Intersection ID: 18943	Main Street: GATE_POST_RD	Cross Street: RAMA_RD	Location:	E
ADA ID: B6C7EC13C824	Ramp Type: PerpDiag	Initial Pass/Fail: Fail	Overall Compliance: No	Severity Score: 12.5
Codes/Mitigation Info/Possible Solution		Field Measurements/Component Compliance

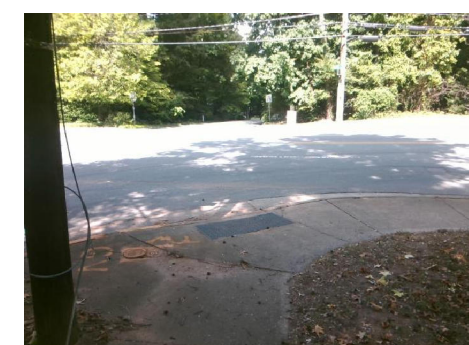
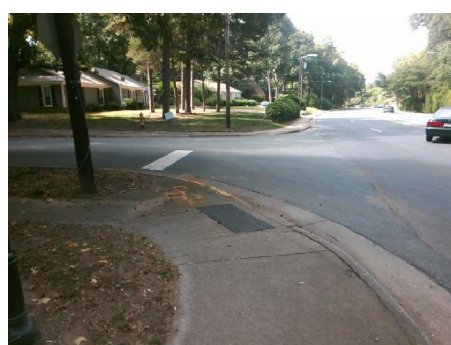
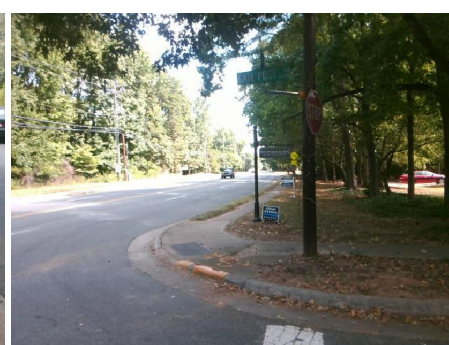
Compliance	Description	Data	Compliance	Description	Data
N/A	Ramp Length (in)	70.0	Yes	Ramp Slope (%)	5.8
Yes	Ramp Width (in)	48.0	No	Ramp XSlope (%)	5.7
N/A	Flare Type LT	N/A	N/A	Flare Type RT	N/A
N/A	Flare Slope LT (%)	N/A	N/A	Flare Slope RT (%)	N/A
N/A	Flare Traversable LT?	N/A	N/A	Flare Traversable RT?	N/A
N/A	Landing Length (in)	N/A	N/A	DWS Provided?	N/A
N/A	Landing Width (in)	N/A	N/A	DWS Contrast?	N/A
N/A	Landing Slope (%)	N/A	N/A	DWS Length (in)	N/A
N/A	Landing X Slope (%)	N/A	N/A	DWS Full Width?	N/A
N/A	Landing Curb? (Y/N)	N/A	N/A	DWS Offset (in)	N/A
N/A	Shared Landing?	N/A			
N/A	Gutter Ponding?	N/A	N/A	Gutter Slope (%)	N/A
N/A	Gutter Lip Ht (in)	N/A	N/A	Gutter X Slope (%)	N/A
N/A	Painted X Walk1?	No	N/A	Painted X Walk2?	No
	X Walk 1 Direction	To NW		X Walk 2 Direction	To SW
N/A	X Walk 1 Width (in)	N/A	N/A	X Walk 2 Width (in)	N/A
	X Walk 1 Slope (%)	1.8		X Walk 2 Slope (%)	1.1
	X Walk 1 X Slope (%)	0.6		X Walk 2 X Slope (%)	1.8

N/A	Ramp inside XWalk1?	N/A	N/A	Ramp inside XWalk2?	N/A
	Road Slope (%)	2.3	N/A	Clear Space?	N/A
	Road X Slope (%)	0.7	N/A	Clear Space to XWalk (in)	N/A
N/A	Any Obstructions?	N/A	N/A	Storm Grate/Utility Hazard?	N/A
	Obstruction Type			Storm Grate/Utility Type	
		N/A			N/A
			Yes	Surface Condition? (G/P)	Good

**Remove & Replace Curb Ramp With Two New Directional Ramps or Equivalent.**

**Not Found, R304.5.3**
