Access Compliance Report

Public Rights-of-Way (Curb Ramps)

Intersection ID: 20238	Main Street: PROVIDENCE_RD	Cross Street: SHELTON_ST	Location: NE
ADA ID: B6C8792E636C	Ramp Type: PerpDiag	Initial Pass/Fail: Fail	Overall Compliance: No
Severity Score: 8.75			
Codes/Mitigation Info/Possible Solution		Field Measurements/Component Compliance

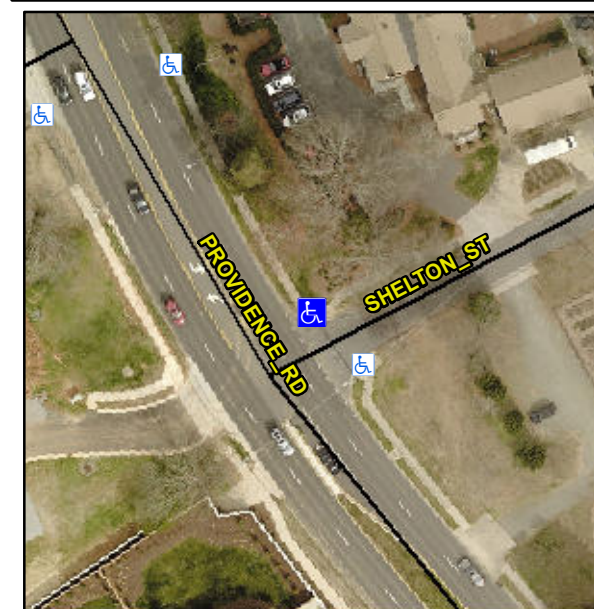
Not Found, R304.5.1

Compliance	Description	Data	Compliance	Description	Data
N/A	Ramp Length (in)	60.0	Yes	Ramp Slope (%)	5.2
No	Ramp Width (in)	38.0	Yes	Ramp XSlope (%)	1.4
N/A	Flare Type LT	N/A	N/A	Flare Type RT	N/A
N/A	Flare Slope LT (%)	N/A	N/A	Flare Slope RT (%)	N/A
N/A	Flare Traversable LT?	N/A	N/A	Flare Traversable RT?	N/A
N/A	Landing Length (in)	N/A	N/A	DWS Provided?	N/A
N/A	Landing Width (in)	N/A	N/A	DWS Contrast?	N/A
N/A	Landing Slope (%)	N/A	N/A	DWS Length (in)	N/A
N/A	Landing X Slope (%)	N/A	N/A	DWS Full Width?	N/A
N/A	Landing Curb? (Y/N)	N/A	N/A	DWS Offset (in)	N/A
N/A	Shared Landing?	N/A			
N/A	Gutter Ponding?	N/A	N/A	Gutter Slope (%)	N/A
N/A	Gutter Lip Ht (in)	N/A	N/A	Gutter X Slope (%)	N/A
N/A	Painted X Walk1?	No	N/A	Painted X Walk2?	No
	X Walk 1 Direction	To SW		X Walk 2 Direction	To SE
N/A	X Walk 1 Width (in)	N/A	N/A	X Walk 2 Width (in)	N/A
	X Walk 1 Slope (%)	3.1		X Walk 2 Slope (%)	0.5
	X Walk 1 X Slope (%)	2.1		X Walk 2 X Slope (%)	3.0

N/A	Ramp inside XWalk1?	N/A	N/A	Ramp inside XWalk2?	N/A
	Road Slope (%)	2.7	N/A	Clear Space?	N/A
	Road X Slope (%)	2.6	N/A	Clear Space to XWalk (in)	N/A
N/A	Any Obstructions?	N/A	N/A	Storm Grate/Utility Hazard?	N/A
	Obstruction Type			Storm Grate/Utility Type	
		N/A			N/A
		Yes		Surface Condition? (G/P)	Good

Remove & Replace Curb Ramp With Two New Directional Ramps or Equivalent.
