# Access Compliance Report

## Public Rights-of-Way

### (Curb Ramps)

Intersection ID: 47396	Main Street: FLAT_RIVER_DR	Cross Street: FLAT_RIVER_DR	Location:	N
ADA ID: B6CCECB16BA2	Ramp Type: Perp	Initial Pass/Fail: Fail	Overall Compliance: No	Severity Score: 12.5

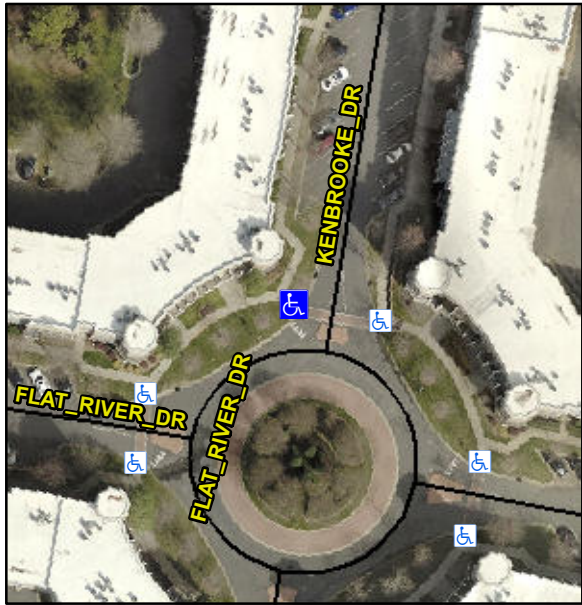
Possible Solutions:		<b>Compliance</b>	<b>Description</b>	<b>Data</b>	<b>Compliance</b>	<b>Description</b>	<b>Data</b>
	<b>Remove &amp; Replace Entire Ramp.</b>		N/A	Ramp Length (in)	58.5	No	Ramp Slope (%)	8.7
			Yes	Ramp Width (in)	48.0	Yes	Ramp XSlope (%)	1.7
			N/A	Flare Type LT	N/A	N/A	Flare Type RT	N/A
			N/A	Flare Slope LT (%)	N/A	N/A	Flare Slope RT (%)	N/A
			N/A	Flare Traversable LT?	N/A	N/A	Flare Traversable RT?	N/A
			N/A	Landing Length (in)	N/A	N/A	DWS Provided?	N/A
			N/A	Landing Width (in)	N/A	N/A	DWS Contrast?	N/A
			N/A	Landing Slope (%)	N/A	N/A	DWS Length (in)	N/A
			N/A	Landing X Slope (%)	N/A	N/A	DWS Full Width?	N/A
Surveyor Notes:	<b>N/A</b>		N/A	Landing Curb? (Y/N)	N/A	N/A	DWS Offset (in)	N/A
			N/A	Shared Landing?	N/A			
			N/A	Gutter Ponding?	N/A	N/A	Gutter Slope (%)	N/A
			N/A	Gutter Lip Ht (in)	N/A	N/A	Gutter X Slope (%)	N/A

N/A	Painted X Walk1?	Yes	N/A	Painted X Walk2?	N/A
				X Walk 1 Direction	To E		X Walk 2 Direction	N/A
			N/A	X Walk 1 Width (in)	51.0	N/A	X Walk 2 Width (in)	N/A
				X Walk 1 Slope (%)	6.7		X Walk 2 Slope (%)	N/A
				X Walk 1 X Slope (%)	6.0		X Walk 2 X Slope (%)	N/A
			N/A	Ramp inside XWalk1?	Yes	N/A	Ramp inside XWalk2?	N/A
PROW/ADA:	<b>R304.2.2</b>			Road Slope (%)	N/A	N/A	Clear Space?	N/A
				Road X Slope (%)	N/A	N/A	Clear Space to XWalk (in)	N/A
			N/A	Any Obstructions?	N/A	N/A	Storm Grate/Utility Hazard?	N/A
				Obstruction Type			Storm Grate/Utility Type	
						N/A		N/A
						Yes	Surface Condition? (G/P)	Good
	Total Cost:		\$	1850.00
