# Access Compliance Report

## Public Rights-of-Way

### (Curb Ramps)

Intersection ID: 12192	Main Street: KILBORNE_DR	Cross Street: WINDHAM_PL	Location: SE
ADA ID: B6CCF58E735E	Ramp Type: Perp	Initial Pass/Fail: Fail	Overall Compliance: No
Severity Score: 10			
Codes/Mitigation Info/Possible Solution		Field Measurements/Component Compliance

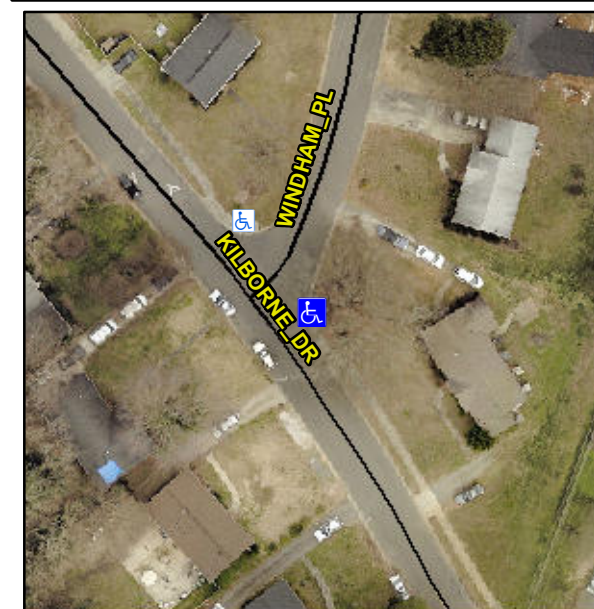
**Not Found, R304.5.1, R304.5.3**

Compliance	Description	Data	Compliance	Description	Data
N/A	Ramp Length (in)	50.0	Yes	Ramp Slope (%)	6.0
No	Ramp Width (in)	44.0	No	Ramp XSlope (%)	3.4
N/A	Flare Type LT	N/A	N/A	Flare Type RT	N/A
N/A	Flare Slope LT (%)	N/A	N/A	Flare Slope RT (%)	N/A
N/A	Flare Traversable LT?	N/A	N/A	Flare Traversable RT?	N/A
N/A	Landing Length (in)	N/A	N/A	DWS Provided?	N/A
N/A	Landing Width (in)	N/A	N/A	DWS Contrast?	N/A
N/A	Landing Slope (%)	N/A	N/A	DWS Length (in)	N/A
N/A	Landing X Slope (%)	N/A	N/A	DWS Full Width?	N/A
N/A	Landing Curb? (Y/N)	N/A	N/A	DWS Offset (in)	N/A
N/A	Shared Landing?	N/A			
N/A	Gutter Ponding?	N/A	N/A	Gutter Slope (%)	N/A
N/A	Gutter Lip Ht (in)	N/A	N/A	Gutter X Slope (%)	N/A
N/A	Painted X Walk1?	No	N/A	Painted X Walk2?	N/A
	X Walk 1 Direction	To NW		X Walk 2 Direction	N/A
N/A	X Walk 1 Width (in)	N/A	N/A	X Walk 2 Width (in)	N/A
	X Walk 1 Slope (%)	5.3		X Walk 2 Slope (%)	N/A
	X Walk 1 X Slope (%)	1.0		X Walk 2 X Slope (%)	N/A

N/A	Ramp inside XWalk1?	N/A	N/A	Ramp inside XWalk2?	N/A
	Road Slope (%)	N/A	N/A	Clear Space?	N/A
	Road X Slope (%)	N/A	N/A	Clear Space to XWalk (in)	N/A
N/A	Any Obstructions?	N/A	N/A	Storm Grate/Utility Hazard?	N/A
	Obstruction Type			Storm Grate/Utility Type	
		N/A			N/A
			Yes	Surface Condition? (G/P)	Good

**Remove & Replace Entire Ramp.**

Total Cost: \$ 1850.00
