# Access Compliance Report

## Public Rights-of-Way

### (Curb Ramps)

| Intersection ID: 10894 | Main Street: MILTON_RD | Cross Street: OAK_FOREST_DR | Location: W |

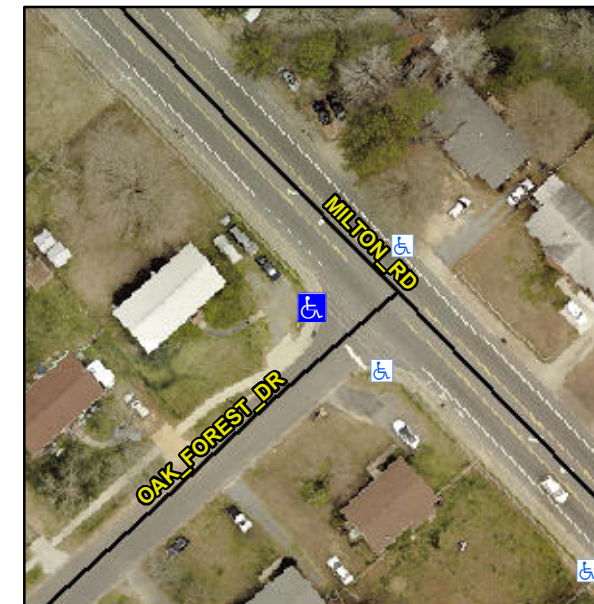
| Severity Score: 31.25 | | | |

**Not Found, R304.5.1, R304.2.2, R304.5.3**

| Compliance | Description | Data | Compliance | Description | Data |
|---|---|---|---|---|---|
| N/A | Ramp Length (in) | 59.0 | No | Ramp Slope (%) | 9.2 |
| No | Ramp Width (in) | 35.5 | No | Ramp XSlope (%) | 3.7 |

Possible Solutions:

**Remove & Replace Curb Ramp With Two New Directional Ramps or Equivalent.**

Total Cost: \$ 3200.00
