Intersection ID: 48018	Main Street: ROYAL_CASTLE_CT	Cross Street: TULLY_HOUSE_CT	Location:	NE
ADA ID: B6D741414CED	Ramp Type: PerpDiag	Initial Pass/Fail: Fail	Overall Compliance: No	Severity Score: 21.25

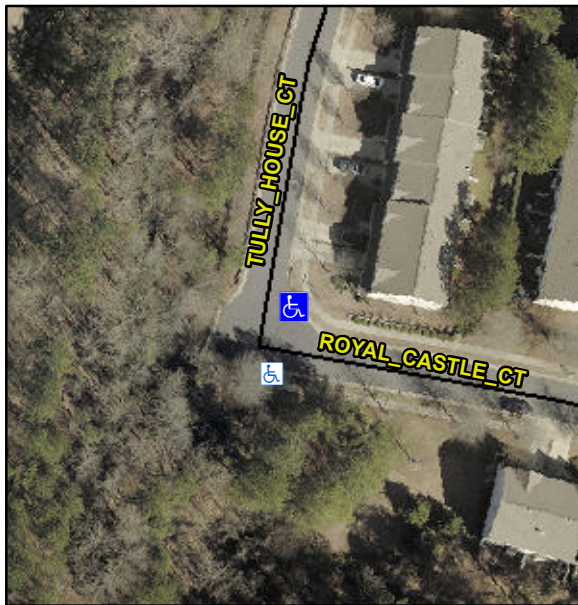
Not Found, R304.5.1, R304.5.3

Compliance	Description	Data	Compliance	Description	Data
N/A	Ramp Length (in)	47.0	Yes	Ramp Slope (%)	5.3
No	Ramp Width (in)	41.0	No	Ramp XSlope (%)	5.1
N/A	Flare Type LT	N/A	N/A	Flare Type RT	N/A
N/A	Flare Slope LT (%)	N/A	N/A	Flare Slope RT (%)	N/A
N/A	Flare Traversable LT?	N/A	N/A	Flare Traversable RT?	N/A
N/A	Landing Length (in)	N/A	N/A	DWS Provided?	N/A
N/A	Landing Width (in)	N/A	N/A	DWS Contrast?	N/A
N/A	Landing Slope (%)	N/A	N/A	DWS Length (in)	N/A
N/A	Landing X Slope (%)	N/A	N/A	DWS Full Width?	N/A
N/A	Landing Curb? (Y/N)	N/A	N/A	DWS Offset (in)	N/A
N/A	Shared Landing?	N/A			
N/A	Gutter Ponding?	N/A	N/A	Gutter Slope (%)	N/A
N/A	Gutter Lip Ht (in)	N/A	N/A	Gutter X Slope (%)	N/A
N/A	Painted X Walk1?	No	N/A	Painted X Walk2?	No
	X Walk 1 Direction	To W		X Walk 2 Direction	To SW
N/A	X Walk 1 Width (in)	N/A	N/A	X Walk 2 Width (in)	N/A
	X Walk 1 Slope (%)	0.7		X Walk 2 Slope (%)	0.3
	X Walk 1 X Slope (%)	1.1		X Walk 2 X Slope (%)	3.2

N/A	Ramp inside XWalk1?	N/A	N/A	Ramp inside XWalk2?	N/A
	Road Slope (%)	3.3	N/A	Clear Space?	N/A
	Road X Slope (%)	0.4	N/A	Clear Space to XWalk (in)	N/A
N/A	Any Obstructions?	N/A	N/A	Storm Grate/Utility Hazard?	N/A
	Obstruction Type			Storm Grate/Utility Type	
		N/A			N/A
			Yes	Surface Condition? (G/P)	Good

Possible Solutions:

Remove & Replace Curb Ramp With Two New Directional Ramps or Equivalent.
