# Access Compliance Report

## Public Rights-of-Way

| Intersection ID: 9547 | Main Street: GENESIS_PARK_PL | Cross Street: PEACEFUL_WAY_DR | Location: E |
| ADA ID: B6D92E4345B3 | Ramp Type: PerpDiag | Initial Pass/Fail: Fail | Overall Compliance: No |

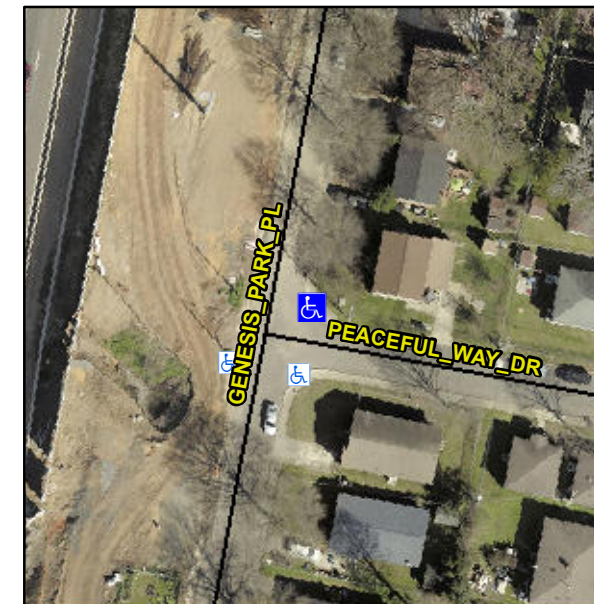
| Severity Score: 35 | | | |

**R304.5.1, R304.2.2, R304.5.3**

| Compliance | Description | Data | Compliance | Description | Data |
|---|---|---|---|---|---|
| N/A | Ramp Length (in) | 65.5 | No | Ramp Slope (%) | 13.7 |
| No | Ramp Width (in) | 38.5 | No | Ramp XSlope (%) | 4.1 |

**Remove & Replace Curb Ramp With Two New Directional Ramps or Equivalent.**

Total Cost: \$ 3200.00
