Access Compliance Report

Public Rights-of-Way

(Curb Ramps)

Intersection ID: 3171	Main Street: ROBYNS_GLEN_DR	Cross Street: SONG_SPARROW_LN	Location: W
ADA ID: B6E95B183B48	Ramp Type: Perp	Initial Pass/Fail: Fail	Overall Compliance: No
Codes/Mitigation Info/Possible Solution		Field Measurements/Component Compliance	
Severity Score: 26.25

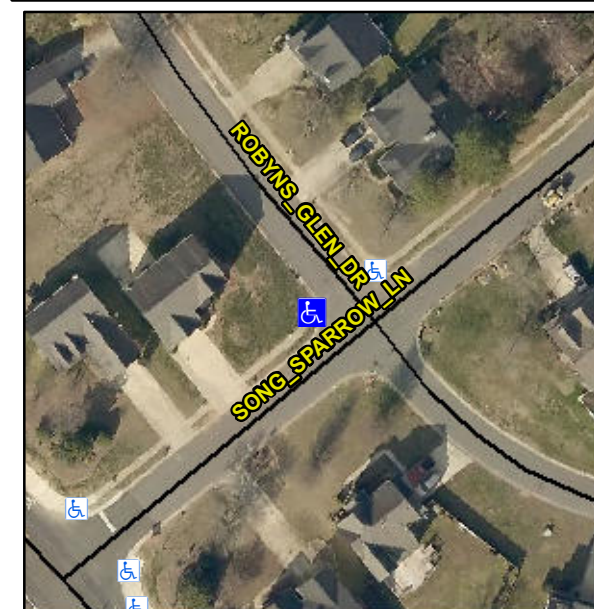
R304.2.2, R304.5.3

Compliance	Description	Data	Compliance	Description	Data
N/A	Ramp Length (in)	48.0	No	Ramp Slope (%)	12.5
Yes	Ramp Width (in)	72.0	No	Ramp XSlope (%)	2.9
N/A	Flare Type LT	N/A	N/A	Flare Type RT	N/A
N/A	Flare Slope LT (%)	N/A	N/A	Flare Slope RT (%)	N/A
N/A	Flare Traversable LT?	N/A	N/A	Flare Traversable RT?	N/A
N/A	Landing Length (in)	N/A	N/A	DWS Provided?	N/A
N/A	Landing Width (in)	N/A	N/A	DWS Contrast?	N/A
N/A	Landing Slope (%)	N/A	N/A	DWS Length (in)	N/A
N/A	Landing X Slope (%)	N/A	N/A	DWS Full Width?	N/A
N/A	Landing Curb? (Y/N)	N/A	N/A	DWS Offset (in)	N/A
N/A	Shared Landing?	N/A			
N/A	Gutter Ponding?	Yes	N/A	Gutter Slope (%)	N/A
N/A	Gutter Lip Ht (in)	N/A	N/A	Gutter X Slope (%)	N/A
N/A	Painted X Walk1?	No	N/A	Painted X Walk2?	N/A
	X Walk 1 Direction	To NE		X Walk 2 Direction	N/A
N/A	X Walk 1 Width (in)	N/A	N/A	X Walk 2 Width (in)	N/A
	X Walk 1 Slope (%)	0.3		X Walk 2 Slope (%)	N/A
	X Walk 1 X Slope (%)	1.0		X Walk 2 X Slope (%)	N/A

N/A	Ramp inside XWalk1?	N/A	N/A	Ramp inside XWalk2?	N/A
	Road Slope (%)	N/A	N/A	Clear Space?	N/A
	Road X Slope (%)	N/A	N/A	Clear Space to XWalk (in)	N/A
N/A	Any Obstructions?	N/A	N/A	Storm Grate/Utility Hazard?	N/A
	Obstruction Type			Storm Grate/Utility Type	
		N/A			N/A
		Yes		Surface Condition? (G/P)	Good

Possible Solutions:

Remove & Replace Entire Ramp.
