## **Access Compliance Report Public Rights-of-Way** (Curb Ramps)

Intersection ID: 50739 Main Street: JACOB MARTIN DR **Cross Street: LYNN LEE CR** Location: ADA ID: B6E9FA74861F Ramp Type: PerpDiag Initial Pass/Fail: Fail **Overall Compliance: No** Severity Score: 46.25

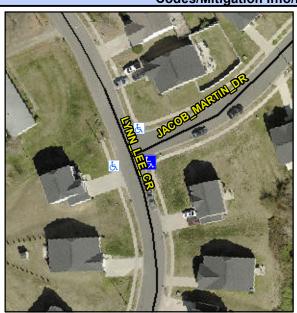
PROW/ADA: Not Found, R304.5.1, R304.2.2,

R304.5.3

Compliance Description Data		Comp	liance Description	Data	
N/A	Ramp Length (in)	47.5	No	Ramp Slope (%)	11.1
No	Ramp Width (in)	45.0	No	Ramp XSlope (%)	7.4
N/A	Flare Type LT	N/A	N/A	Flare Type RT	N/A
N/A	Flare Slope LT (%)	N/A	N/A	Flare Slope RT (%)	N/A
N/A	Flare Traversable LT?	N/A	N/A	Flare Traversable RT?	N/A
N/A	Landing Length (in)	N/A	N/A	DWS Provided?	N/A
N/A	Landing Width (in)	N/A	N/A	DWS Contrast?	N/A
N/A	Landing Slope (%)	N/A	N/A	DWS Length (in)	N/A
N/A	Landing X Slope (%)	N/A	N/A	DWS Full Width?	N/A
N/A	Landing Curb? (Y/N)	N/A	N/A	DWS Offset (in)	N/A
N/A	Shared Landing?	N/A			
N/A	Gutter Ponding?	N/A	N/A	Gutter Slope (%)	N/A
N/A	Gutter Lip Ht (in)	N/A	N/A	Gutter X Slope (%)	N/A
N/A	Painted X Walk1?	No	N/A	Painted X Walk2?	No
	X Walk 1 Direction	To N		X Walk 2 Direction	To W
N/A	X Walk 1 Width (in)	N/A	N/A	X Walk 2 Width (in)	N/A
	X Walk 1 Slope (%)	0.2		X Walk 2 Slope (%)	4.6
	X Walk 1 X Slope (%)	6.2		X Walk 2 X Slope (%)	1.5

N/A	Ramp inside XWalk1?	N/A	N/A	Ramp inside XWalk2?	N/A
	Road Slope (%)	7.2	N/A	Clear Space?	N/A
	Road X Slope (%)	4.1	N/A	Clear Space to XWalk (in)	N/A
N/A	Any Obstructions?	N/A	N/A	Storm Grate/Utility Hazard?	N/A
	Obstruction Type			Storm Grate/Utility Type	
		N/A			N/A
			Yes	Surface Condition? (G/P)	Good

Possible Solutions: Remove & Replace Curb Ramp With **Two New Directional Ramps or** Equivalent. Surveyor Notes: N/A
