Access Compliance Report

Public Rights-of-Way

(Curb Ramps)

Intersection ID: 4036	Main Street: SHADY_REACH_LN	Cross Street: STONY_PATH_DR	Location: W
ADA ID: B6ED9A6CACCA	Ramp Type: Perp	Initial Pass/Fail: Fail	Overall Compliance: No
Severity Score: 10			
Codes/Mitigation Info/Possible Solution		Field Measurements/Component Compliance

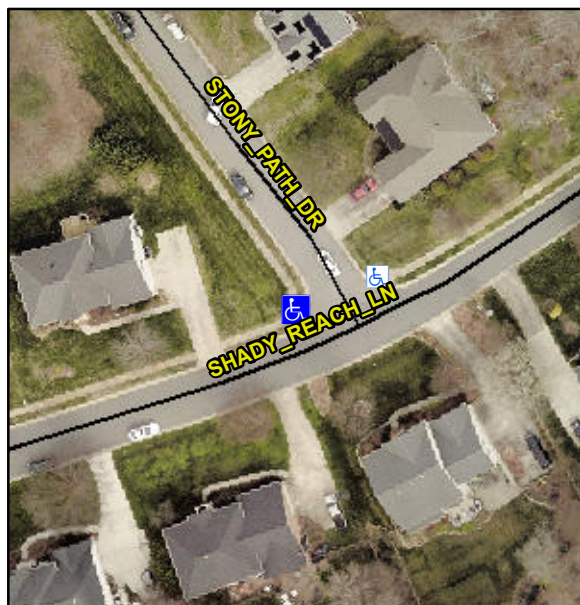
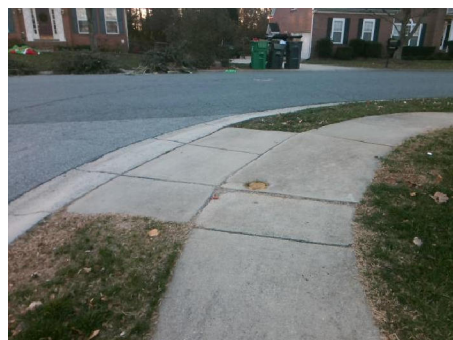
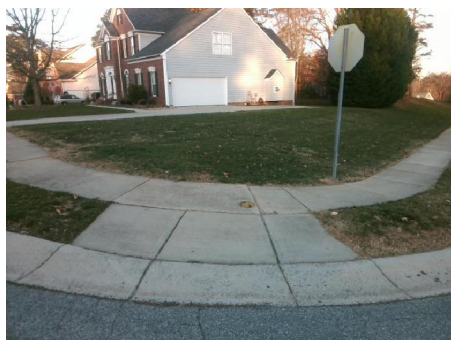
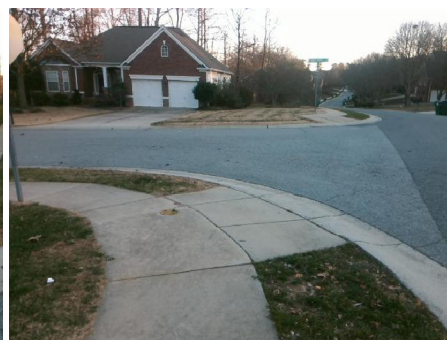
Not Found, R304.5.1, R304.5.3

Compliance	Description	Data	Compliance	Description	Data
N/A	Ramp Length (in)	48.0	Yes	Ramp Slope (%)	7.3
No	Ramp Width (in)	38.0	No	Ramp XSlope (%)	5.0
N/A	Flare Type LT	N/A	N/A	Flare Type RT	N/A
N/A	Flare Slope LT (%)	N/A	N/A	Flare Slope RT (%)	N/A
N/A	Flare Traversable LT?	N/A	N/A	Flare Traversable RT?	N/A
N/A	Landing Length (in)	N/A	N/A	DWS Provided?	N/A
N/A	Landing Width (in)	N/A	N/A	DWS Contrast?	N/A
N/A	Landing Slope (%)	N/A	N/A	DWS Length (in)	N/A
N/A	Landing X Slope (%)	N/A	N/A	DWS Full Width?	N/A
N/A	Landing Curb? (Y/N)	N/A	N/A	DWS Offset (in)	N/A
N/A	Shared Landing?	N/A			
N/A	Gutter Ponding?	N/A	N/A	Gutter Slope (%)	N/A
N/A	Gutter Lip Ht (in)	N/A	N/A	Gutter X Slope (%)	N/A
N/A	Painted X Walk1?	No	N/A	Painted X Walk2?	N/A
	X Walk 1 Direction	To E		X Walk 2 Direction	N/A
N/A	X Walk 1 Width (in)	N/A	N/A	X Walk 2 Width (in)	N/A
	X Walk 1 Slope (%)	2.9		X Walk 2 Slope (%)	N/A
	X Walk 1 X Slope (%)	1.5		X Walk 2 X Slope (%)	N/A

N/A	Ramp inside XWalk1?	N/A	N/A	Ramp inside XWalk2?	N/A
	Road Slope (%)	N/A	N/A	Clear Space?	N/A
	Road X Slope (%)	N/A	N/A	Clear Space to XWalk (in)	N/A
N/A	Any Obstructions?	N/A	N/A	Storm Grate/Utility Hazard?	N/A
	Obstruction Type			Storm Grate/Utility Type	
		N/A			N/A
			Yes	Surface Condition? (G/P)	Good

Remove & Replace Entire Ramp.

Total Cost: \$ 1850.00
