# Access Compliance Report

## Public Rights-of-Way (Curb Ramps)

| Intersection ID: 52911 | Main Street: CLEMS_CREEK_LN | Cross Street: CLEMS_CROSSING_DR | Location: NW |
| ADA ID: B704DFF72C41 | Ramp Type: BlendTrans1 | Initial Pass/Fail: Pass | Overall Compliance: No |

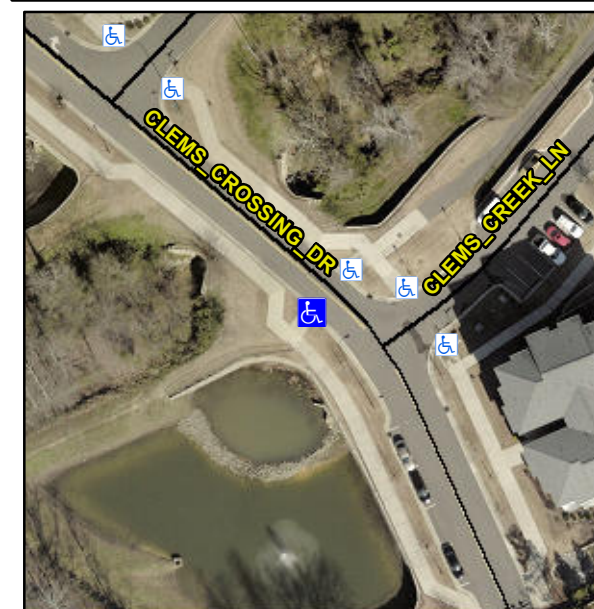
| Compliance | Description | Data | Compliance | Description | Data |
|---|---|---|---|---|---|
| No | Landing Slope (%) | 3.2 | Yes | DWS Length (in) | 24.0 |
| N/A | Landing Curb? (Y/N) | No | No | DWS Offset (in) | 4.5 |

**Remove & Replace Curb Ramp With Two New Directional Ramps or Equivalent.**

**R304.2.2-Perp, R304.3.2-Para, R305.2**
