Access Compliance Report

Public Rights-of-Way

(Curb Ramps)

Intersection ID: 21454	Main Street: SARDIS_RD_NORTH	Cross Street: MAPLE_SHADE_LN	Location: NW
ADA ID: B711EA8E29D4	Ramp Type: PerpDiag	Initial Pass/Fail: Fail	Overall Compliance: No
Severity Score: 37.5			
Codes/Mitigation Info/Possible Solution		Field Measurements/Component Compliance

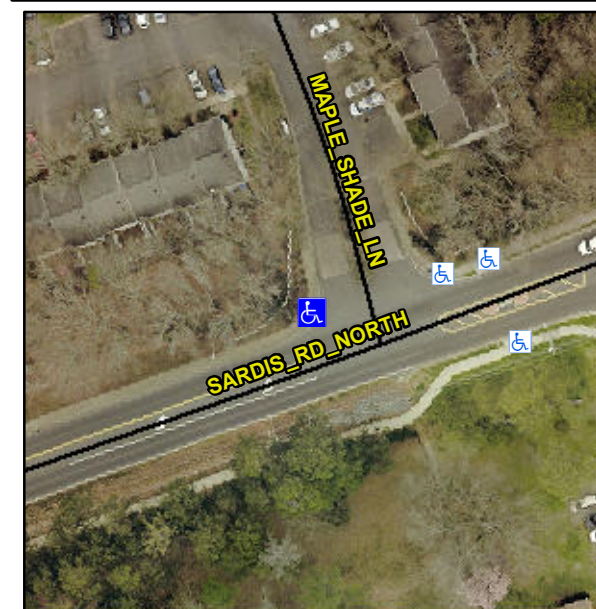
Compliance	Description	Data	Compliance	Description	Data
N/A	Ramp Length (in)	60.0	No	Ramp Slope (%)	12.1
Yes	Ramp Width (in)	48.0	No	Ramp XSlope (%)	6.7
N/A	Flare Type LT	N/A	N/A	Flare Type RT	N/A
N/A	Flare Slope LT (%)	N/A	N/A	Flare Slope RT (%)	N/A
N/A	Flare Traversable LT?	N/A	N/A	Flare Traversable RT?	N/A
N/A	Landing Length (in)	N/A	N/A	DWS Provided?	N/A
N/A	Landing Width (in)	N/A	N/A	DWS Contrast?	N/A
N/A	Landing Slope (%)	N/A	N/A	DWS Length (in)	N/A
N/A	Landing X Slope (%)	N/A	N/A	DWS Full Width?	N/A
N/A	Landing Curb? (Y/N)	N/A	N/A	DWS Offset (in)	N/A
N/A	Shared Landing?	N/A			
N/A	Gutter Ponding?	N/A	N/A	Gutter Slope (%)	N/A
N/A	Gutter Lip Ht (in)	N/A	N/A	Gutter X Slope (%)	N/A
N/A	Painted X Walk1?	No	N/A	Painted X Walk2?	No
	X Walk 1 Direction	To S		X Walk 2 Direction	To E
N/A	X Walk 1 Width (in)	N/A	N/A	X Walk 2 Width (in)	N/A
	X Walk 1 Slope (%)	6.8		X Walk 2 Slope (%)	2.3
	X Walk 1 X Slope (%)	0.8		X Walk 2 X Slope (%)	7.7

N/A	Ramp inside XWalk1?	N/A	N/A	Ramp inside XWalk2?	N/A
	Road Slope (%)	4.3	N/A	Clear Space?	N/A
	Road X Slope (%)	6.0	N/A	Clear Space to XWalk (in)	N/A
N/A	Any Obstructions?	N/A	N/A	Storm Grate/Utility Hazard?	N/A
	Obstruction Type			Storm Grate/Utility Type	
		N/A			N/A
			Yes	Surface Condition? (G/P)	Good

Remove & Replace Curb Ramp With Two New Directional Ramps or Equivalent.

R304.2.2, R304.5.3
