# Access Compliance Report

## Public Rights-of-Way

### (Curb Ramps)

Intersection ID: N/A	Main Street: WINDSOR_GATE_LN	Cross Street: W_T_HARRIS_BV	Location: NE
ADA ID: B716F0174093	Ramp Type: PerpDiag	Initial Pass/Fail: Fail	Overall Compliance: No
Codes/Mitigation Info/Possible Solution		Field Measurements/Component Compliance

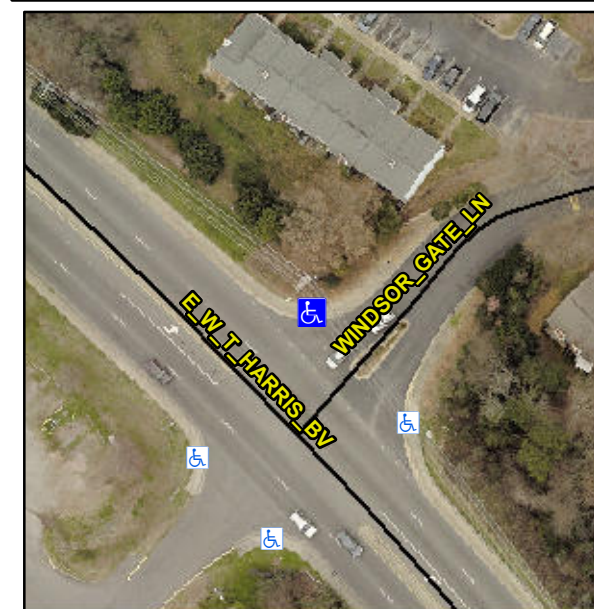
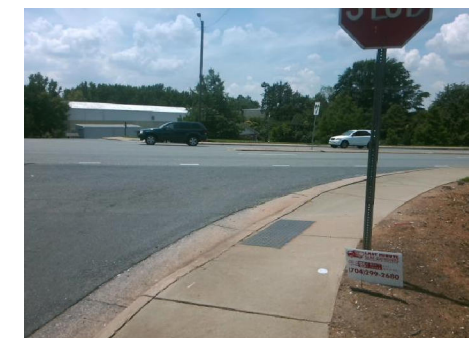
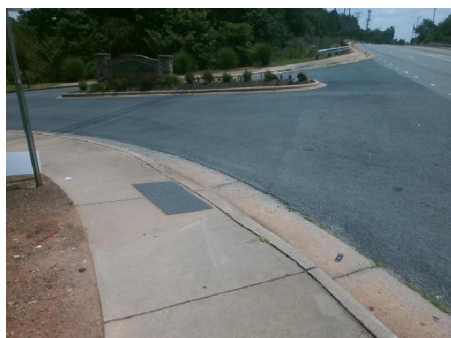
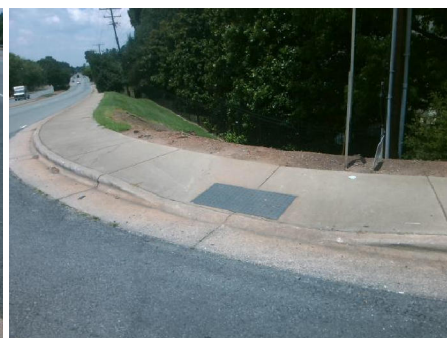
**Not Found, R304.2.2, R304.5.3**

Compliance	Description	Data	Compliance	Description	Data
N/A	Ramp Length (in)	60.0	No	Ramp Slope (%)	10.4
Yes	Ramp Width (in)	80.0	No	Ramp XSlope (%)	5.0
N/A	Flare Type LT	N/A	N/A	Flare Type RT	N/A
N/A	Flare Slope LT (%)	N/A	N/A	Flare Slope RT (%)	N/A
N/A	Flare Traversable LT?	N/A	N/A	Flare Traversable RT?	N/A
N/A	Landing Length (in)	N/A	N/A	DWS Provided?	N/A
N/A	Landing Width (in)	N/A	N/A	DWS Contrast?	N/A
N/A	Landing Slope (%)	N/A	N/A	DWS Length (in)	N/A
N/A	Landing X Slope (%)	N/A	N/A	DWS Full Width?	N/A
N/A	Landing Curb? (Y/N)	N/A	N/A	DWS Offset (in)	N/A
N/A	Shared Landing?	N/A			
N/A	Gutter Ponding?	N/A	N/A	Gutter Slope (%)	N/A
N/A	Gutter Lip Ht (in)	N/A	N/A	Gutter X Slope (%)	N/A
N/A	Painted X Walk1?	No	N/A	Painted X Walk2?	No
	X Walk 1 Direction	To SW		X Walk 2 Direction	To SE
N/A	X Walk 1 Width (in)	N/A	N/A	X Walk 2 Width (in)	N/A
	X Walk 1 Slope (%)	6.4		X Walk 2 Slope (%)	5.8
	X Walk 1 X Slope (%)	4.4		X Walk 2 X Slope (%)	7.1

N/A	Ramp inside XWalk1?	N/A	N/A	Ramp inside XWalk2?	N/A
	Road Slope (%)	4.6	N/A	Clear Space?	N/A
	Road X Slope (%)	7.9	N/A	Clear Space to XWalk (in)	N/A
N/A	Any Obstructions?	N/A	N/A	Storm Grate/Utility Hazard?	N/A
	Obstruction Type			Storm Grate/Utility Type	
		N/A			N/A
			Yes	Surface Condition? (G/P)	Good

**Remove & Replace Curb Ramp With Two New Directional Ramps or Equivalent.**
