Access Compliance Report

Public Rights-of-Way

(Curb Ramps)

Intersection ID: 11676	Main Street: HAWTHORNE_LN	Cross Street: PARKWOOD_AV	Location: SW
ADA ID: B717C4017119	Ramp Type: Perp	Initial Pass/Fail: Fail	Overall Compliance: No
		Severity Score: 10

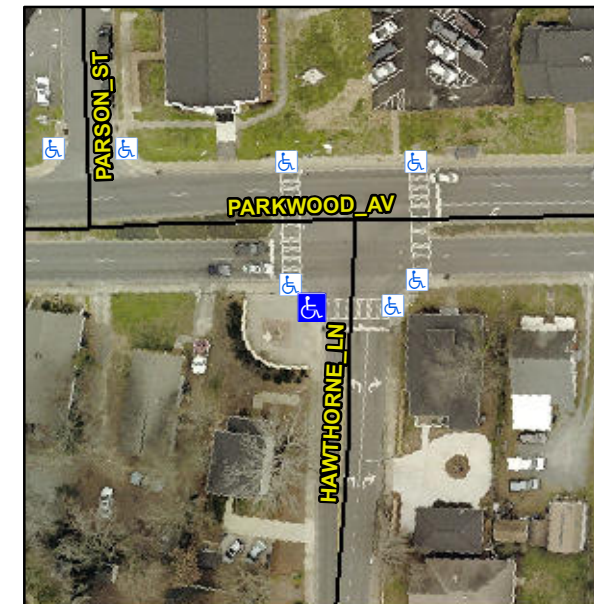
Not Found, R304.5.1, R304.5.3

Compliance	Description	Data	Compliance	Description	Data
N/A	Ramp Length (in)	50.0	Yes	Ramp Slope (%)	7.1
No	Ramp Width (in)	47.0	No	Ramp XSlope (%)	2.7
N/A	Flare Type LT	N/A	N/A	Flare Type RT	N/A
N/A	Flare Slope LT (%)	N/A	N/A	Flare Slope RT (%)	N/A
N/A	Flare Traversable LT?	N/A	N/A	Flare Traversable RT?	N/A
N/A	Landing Length (in)	N/A	N/A	DWS Provided?	N/A
N/A	Landing Width (in)	N/A	N/A	DWS Contrast?	N/A
N/A	Landing Slope (%)	N/A	N/A	DWS Length (in)	N/A
N/A	Landing X Slope (%)	N/A	N/A	DWS Full Width?	N/A
N/A	Landing Curb? (Y/N)	N/A	N/A	DWS Offset (in)	N/A
N/A	Shared Landing?	N/A			
N/A	Gutter Ponding?	N/A	N/A	Gutter Slope (%)	N/A
N/A	Gutter Lip Ht (in)	0.5	N/A	Gutter X Slope (%)	N/A
N/A	Painted X Walk1?	Yes	N/A	Painted X Walk2?	N/A
	X Walk 1 Direction	To E		X Walk 2 Direction	N/A
N/A	X Walk 1 Width (in)	108.0	N/A	X Walk 2 Width (in)	N/A
	X Walk 1 Slope (%)	3.1		X Walk 2 Slope (%)	N/A
	X Walk 1 X Slope (%)	2.4		X Walk 2 X Slope (%)	N/A

N/A	Ramp inside XWalk1?	Yes	N/A	Ramp inside XWalk2?	N/A
	Road Slope (%)	2.4	N/A	Clear Space?	N/A
	Road X Slope (%)	3.1	N/A	Clear Space to XWalk (in)	N/A
N/A	Any Obstructions?	N/A	N/A	Storm Grate/Utility Hazard?	N/A
	Obstruction Type			Storm Grate/Utility Type	
		N/A			N/A
		Yes		Surface Condition? (G/P)	Good

Remove & Replace Entire Ramp.
