# Access Compliance Report

## Public Rights-of-Way

### (Curb Ramps)

Intersection ID: 48364	Main Street: RED_COW_RD	Cross Street: SULKY_PLOUGH_RD	Location: NE
ADA ID: B7187394C0C9	Ramp Type: BlendTrans1	Initial Pass/Fail: Fail	Overall Compliance: No
		Severity Score: 12.5

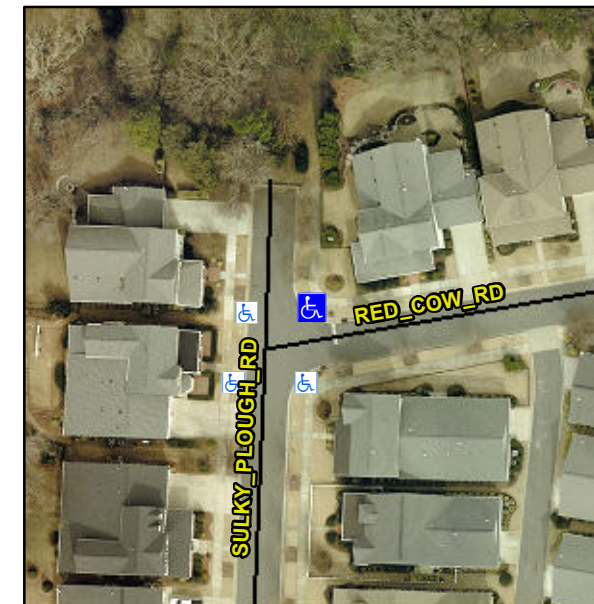
Compliance	Description	Data	Compliance	Description	Data
N/A	Ramp Length (in)	72.0	Yes	BlendTrans Slope (%)	4.5
Yes	Ramp Width (in)	48.0	No	BlendTrans XSlope (%)	5.3
N/A	Flare Type LT	N/A	N/A	Flare Type RT	N/A
N/A	Flare Slope LT (%)	N/A	N/A	Flare Slope RT (%)	N/A
N/A	Flare Traversable LT?	N/A	N/A	Flare Traversable RT?	N/A
N/A	Landing Length (in)	N/A	N/A	DWS Provided?	N/A
N/A	Landing Width (in)	N/A	N/A	DWS Contrast?	N/A
N/A	Landing Slope (%)	N/A	N/A	DWS Length (in)	N/A
N/A	Landing X Slope (%)	N/A	N/A	DWS Full Width?	N/A
N/A	Landing Curb? (Y/N)	N/A	N/A	DWS Offset (in)	N/A
N/A	Shared Landing?	N/A			
N/A	Gutter Ponding?	N/A	N/A	Gutter Slope (%)	N/A
N/A	Gutter Lip Ht (in)	N/A	N/A	Gutter X Slope (%)	N/A
N/A	Painted X Walk1?	No	N/A	Painted X Walk2?	No
	X Walk 1 Direction	To S		X Walk 2 Direction	To W
	X Walk 1 Width (in)	N/A		X Walk 2 Width (in)	N/A
	X Walk 1 Slope (%)	1.1		X Walk 2 Slope (%)	6.9
	X Walk 1 X Slope (%)	6.2		X Walk 2 X Slope (%)	1.3

N/A	Ramp inside XWalk1?	N/A	N/A	Ramp inside XWalk2?	N/A
	Road Slope (%)	4.6		Clear Space?	N/A
	Road X Slope (%)	6.0	N/A	Clear Space to XWalk (in)	N/A
N/A	Any Obstructions?	N/A	N/A	Storm Grate/Utility Hazard?	N/A
	Obstruction Type			Storm Grate/Utility Type	
		N/A			N/A
			Yes	Surface Condition? (G/P)	Good
			No	Curb Slope (%)	8.3

**Remove & Replace Curb Ramp With Two New Directional Ramps or Equivalent.**
