# Access Compliance Report

## Public Rights-of-Way

### (Curb Ramps)

Intersection ID: 31722	Main Street: FILBERT_LN	Cross Street: WEEPING_FIG_LN	Location: NE
ADA ID: B71D7E8B2391	Ramp Type: PerpDiag	Initial Pass/Fail: Fail	Overall Compliance: No
		Severity Score: 30

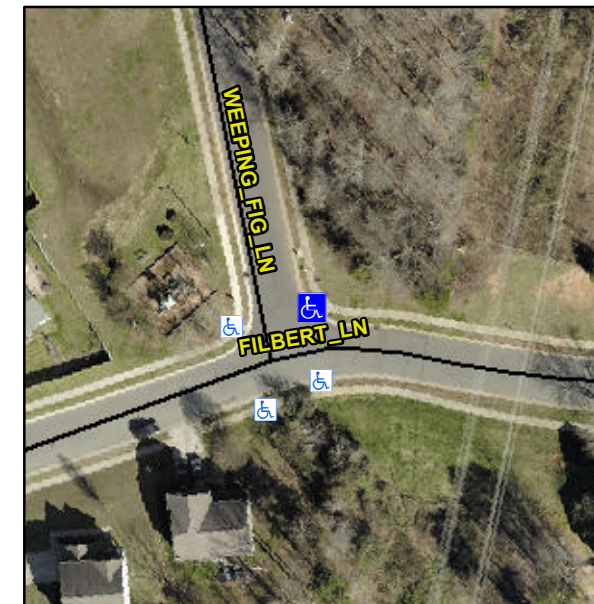
Compliance	Description	Data	Compliance	Description	Data
N/A	Ramp Length (in)	49.0	Yes	Ramp Slope (%)	6.0
No	Ramp Width (in)	35.0	No	Ramp XSlope (%)	5.3
N/A	Flare Type LT	N/A	N/A	Flare Type RT	N/A
N/A	Flare Slope LT (%)	N/A	N/A	Flare Slope RT (%)	N/A
N/A	Flare Traversable LT?	N/A	N/A	Flare Traversable RT?	N/A
N/A	Landing Length (in)	N/A	N/A	DWS Provided?	N/A
N/A	Landing Width (in)	N/A	N/A	DWS Contrast?	N/A
N/A	Landing Slope (%)	N/A	N/A	DWS Length (in)	N/A
N/A	Landing X Slope (%)	N/A	N/A	DWS Full Width?	N/A
N/A	Landing Curb? (Y/N)	N/A	N/A	DWS Offset (in)	N/A
N/A	Shared Landing?	N/A			
N/A	Gutter Ponding?	N/A	N/A	Gutter Slope (%)	N/A
N/A	Gutter Lip Ht (in)	N/A	N/A	Gutter X Slope (%)	N/A
N/A	Painted X Walk1?	No	N/A	Painted X Walk2?	No
	X Walk 1 Direction	To W		X Walk 2 Direction	To S
N/A	X Walk 1 Width (in)	N/A	N/A	X Walk 2 Width (in)	N/A
	X Walk 1 Slope (%)	0.1		X Walk 2 Slope (%)	7.9
	X Walk 1 X Slope (%)	4.5		X Walk 2 X Slope (%)	0.3

N/A	Ramp inside XWalk1?	N/A	N/A	Ramp inside XWalk2?	N/A
	Road Slope (%)	4.9	N/A	Clear Space?	N/A
	Road X Slope (%)	3.9	N/A	Clear Space to XWalk (in)	N/A
N/A	Any Obstructions?	N/A	N/A	Storm Grate/Utility Hazard?	N/A
	Obstruction Type			Storm Grate/Utility Type	
		N/A			N/A
			Yes	Surface Condition? (G/P)	Good

**Remove & Replace Curb Ramp With Two New Directional Ramps or Equivalent.**

**R304.5.1, R304.5.3**
