Access Compliance Report

Public Rights-of-Way

(Curb Ramps)

Intersection ID: 2640	Main Street: BLUE_SKY_LN	Cross Street: FAIRVISTA_DR	Location: W
ADA ID: B73196B4B114	Ramp Type: PerpDiag	Initial Pass/Fail: Fail	Overall Compliance: No
		Severity Score: 22.5

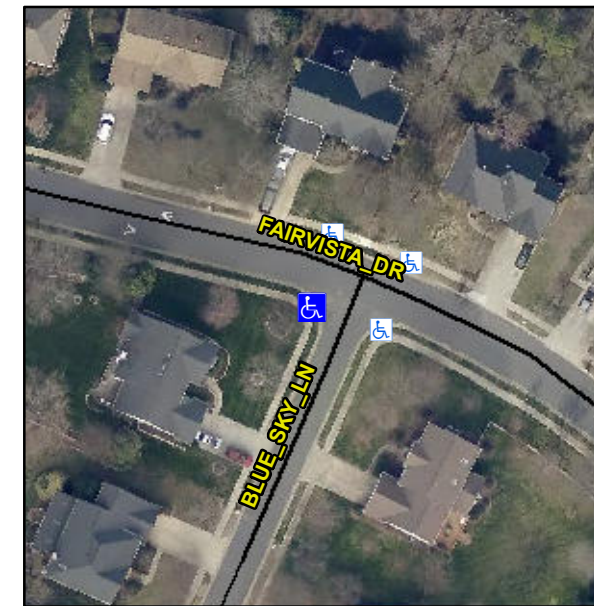
Not Found, R304.5.1, R304.2.2, R304.5.3

Compliance	Description	Data	Compliance	Description	Data
N/A	Ramp Length (in)	45.0	No	Ramp Slope (%)	11.7
No	Ramp Width (in)	41.5	No	Ramp XSlope (%)	4.8
N/A	Flare Type LT	N/A	N/A	Flare Type RT	N/A
N/A	Flare Slope LT (%)	N/A	N/A	Flare Slope RT (%)	N/A
N/A	Flare Traversable LT?	N/A	N/A	Flare Traversable RT?	N/A
N/A	Landing Length (in)	N/A	N/A	DWS Provided?	N/A
N/A	Landing Width (in)	N/A	N/A	DWS Contrast?	N/A
N/A	Landing Slope (%)	N/A	N/A	DWS Length (in)	N/A
N/A	Landing X Slope (%)	N/A	N/A	DWS Full Width?	N/A
N/A	Landing Curb? (Y/N)	N/A	N/A	DWS Offset (in)	N/A
N/A	Shared Landing?	N/A			
N/A	Gutter Ponding?	N/A	N/A	Gutter Slope (%)	N/A
N/A	Gutter Lip Ht (in)	N/A	N/A	Gutter X Slope (%)	N/A
N/A	Painted X Walk1?	No	N/A	Painted X Walk2?	No
	X Walk 1 Direction	To SE		X Walk 2 Direction	To NE
N/A	X Walk 1 Width (in)	N/A	N/A	X Walk 2 Width (in)	N/A
	X Walk 1 Slope (%)	3.1		X Walk 2 Slope (%)	1.2
	X Walk 1 X Slope (%)	4.3		X Walk 2 X Slope (%)	2.7

N/A	Ramp inside XWalk1?	N/A	N/A	Ramp inside XWalk2?	N/A
	Road Slope (%)	3.0	N/A	Clear Space?	N/A
	Road X Slope (%)	1.4	N/A	Clear Space to XWalk (in)	N/A
N/A	Any Obstructions?	N/A	N/A	Storm Grate/Utility Hazard?	N/A
	Obstruction Type			Storm Grate/Utility Type	
		N/A			N/A
			Yes	Surface Condition? (G/P)	Good

Remove & Replace Curb Ramp With Two New Directional Ramps or Equivalent.
