Access Compliance Report

Public Rights-of-Way

(Curb Ramps)

Intersection ID: 9159	Main Street: CAMPUS_ST	Cross Street: TATE_ST	Location: NE
ADA ID: B73944F924D5	Ramp Type: Para	Initial Pass/Fail: Pass	Overall Compliance: No
Codes/Mitigation Info/Possible Solution			Severity Score: 15
			Field Measurements/Component Compliance

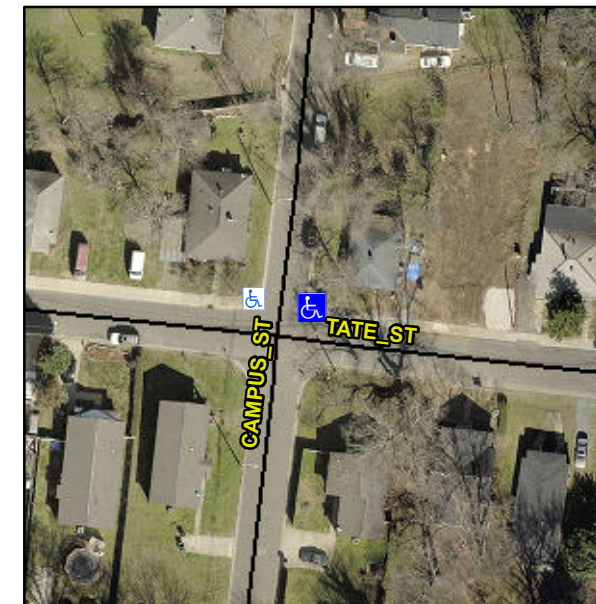
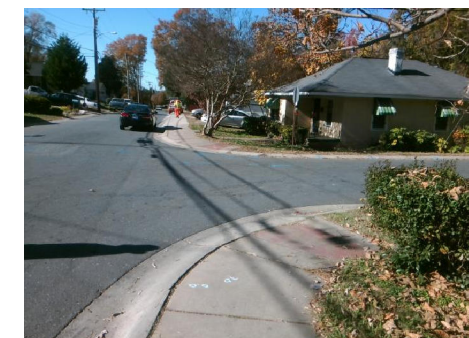
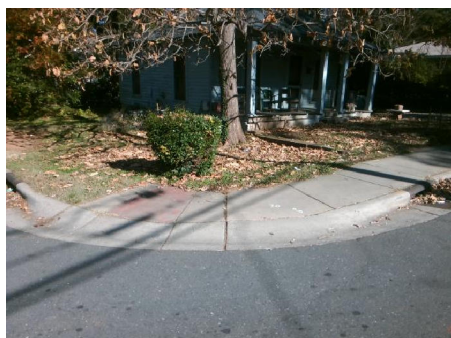
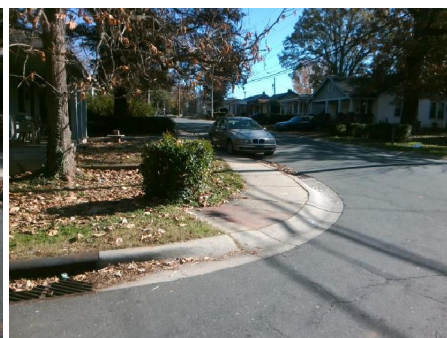
Compliance	Description	Data	Compliance	Description	Data
N/A	Ramp Length LT (in)	N/A	N/A	Ramp Length RT (in)	57.0
N/A	Ramp Width LT (in)	N/A	Yes	Ramp Width RT (in)	52.0
N/A	Ramp Slope LT (%)	N/A	Yes	Ramp Slope RT (%)	7.0
N/A	Ramp XSlope LT (%)	N/A	Yes	Ramp XSlope RT (%)	0.0
Yes	Landing Length (in)	61.0	No	DWS Provided?	No
No	Landing Width (in)	29.0	N/A	DWS Contrast?	No
Yes	Landing Slope (%)	0.9	N/A	DWS Length (in)	N/A
No	Landing X Slope (%)	3.7	N/A	DWS Full Width?	No
N/A	Landing Curb? (Y/N)	No	N/A	DWS Offset (in)	N/A
N/A	Shared Landing?	No			
Yes	Gutter Ponding?	No	No	Gutter Slope (%)	6.7
Yes	Gutter Lip Ht (in)	0.0	No	Gutter X Slope (%)	4.0
N/A	Painted X Walk1?	No	N/A	Painted X Walk2?	N/A
	X Walk 1 Direction	To W		X Walk 2 Direction	N/A
N/A	X Walk 1 Width (in)	N/A	N/A	X Walk 2 Width (in)	N/A
	X Walk 1 Slope (%)	1.4		X Walk 2 Slope (%)	N/A
	X Walk 1 X Slope (%)	3.9		X Walk 2 X Slope (%)	N/A
N/A	Ramp inside XWalk1?	N/A	N/A	Ramp inside XWalk2?	N/A

Road Slope (%)	N/A	N/A	Clear Space?	Yes
	Road X Slope (%)	N/A	N/A	Clear Space to XWalk (in)	N/A
Yes	Any Obstructions?	No	Yes	Storm Grate/Utility Hazard?	No
	Obstruction Type			Storm Grate/Utility Type	
		N/A			N/A
			Yes	Surface Condition? (G/P)	Good
			N/A	Curb Slope (%)	17.0

**Remove & Replace Entire Ramp.
Remove & Replace Gutter.**
