Access Compliance Report

Public Rights-of-Way

(Curb Ramps)

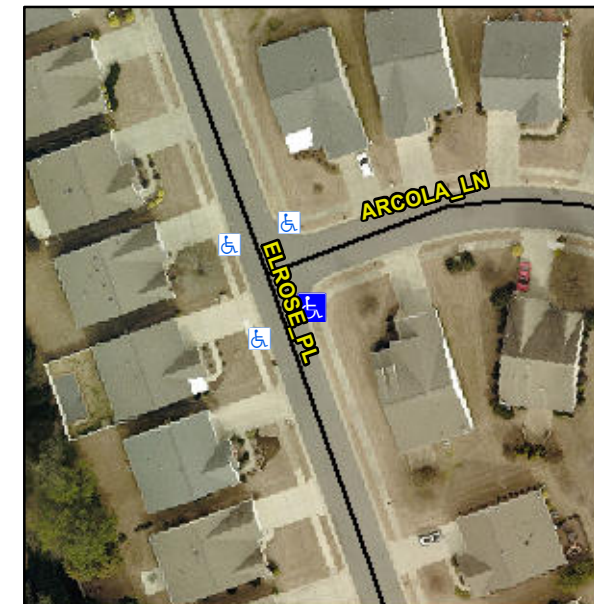
Intersection ID: 44005	Main Street: ARCOLA_LN	Cross Street: ELROSE_PL	Location: SE
ADA ID: B73E1518C92B	Ramp Type: Perp	Initial Pass/Fail: Fail	Overall Compliance: No
Severity Score: 22.5			
Codes/Mitigation Info/Possible Solution		Field Measurements/Component Compliance

Not Found, R304.5.1, R304.2.2, R304.5.3

Compliance	Description	Data	Compliance	Description	Data
N/A	Ramp Length (in)	47.0	No	Ramp Slope (%)	9.9
No	Ramp Width (in)	40.0	No	Ramp XSlope (%)	4.2
N/A	Flare Type LT	N/A	N/A	Flare Type RT	N/A
N/A	Flare Slope LT (%)	N/A	N/A	Flare Slope RT (%)	N/A
N/A	Flare Traversable LT?	N/A	N/A	Flare Traversable RT?	N/A
N/A	Landing Length (in)	N/A	N/A	DWS Provided?	N/A
N/A	Landing Width (in)	N/A	N/A	DWS Contrast?	N/A
N/A	Landing Slope (%)	N/A	N/A	DWS Length (in)	N/A
N/A	Landing X Slope (%)	N/A	N/A	DWS Full Width?	N/A
N/A	Landing Curb? (Y/N)	N/A	N/A	DWS Offset (in)	N/A
N/A	Shared Landing?	N/A			
N/A	Gutter Ponding?	N/A	N/A	Gutter Slope (%)	N/A
N/A	Gutter Lip Ht (in)	0.5	N/A	Gutter X Slope (%)	N/A
N/A	Painted X Walk1?	No	N/A	Painted X Walk2?	N/A
	X Walk 1 Direction	To W		X Walk 2 Direction	N/A
N/A	X Walk 1 Width (in)	N/A	N/A	X Walk 2 Width (in)	N/A
	X Walk 1 Slope (%)	0.4		X Walk 2 Slope (%)	N/A
	X Walk 1 X Slope (%)	0.9		X Walk 2 X Slope (%)	N/A

Remove & Replace Entire Ramp.

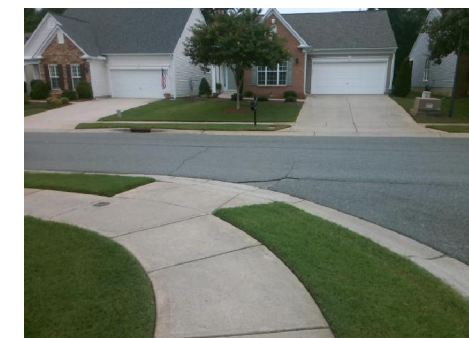
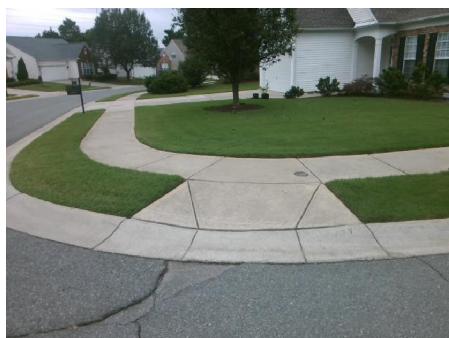
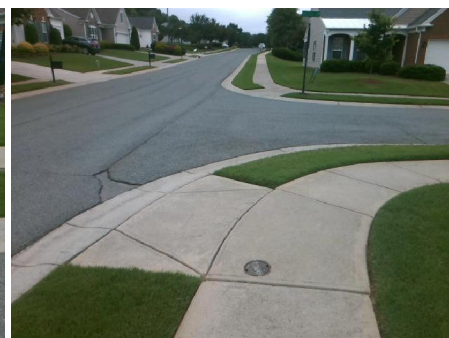
N/A	Ramp inside XWalk1?	N/A	N/A	Ramp inside XWalk2?	N/A
	Road Slope (%)	N/A	N/A	Clear Space?	N/A
	Road X Slope (%)	N/A	N/A	Clear Space to XWalk (in)	N/A
N/A	Any Obstructions?	N/A	N/A	Storm Grate/Utility Hazard?	N/A
	Obstruction Type			Storm Grate/Utility Type	
		N/A			N/A
		Yes		Surface Condition? (G/P)	Good
