## Access Compliance Report Public Rights-of-Way (Curb Ramps)

| Intersection ID: 42469 Mai | Main Street: KINGSLEY_VIEW_DR | | Cross Street: CASTLE_WATCH_AV | | | | Location: | S | |
| ADA ID: B750B9229CEB Rar | Ramp Type: PerpDiag | | Initial Pass/Fail: Fail Overall Compliance: N | | | | o Severity Score: | 42.5 | |

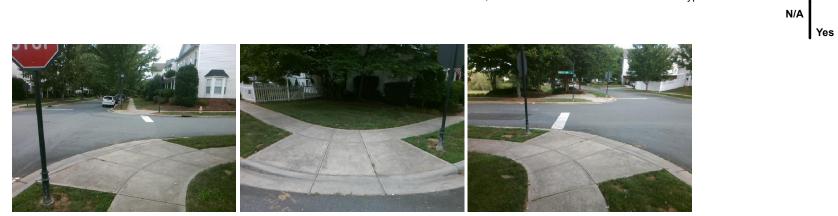
| Intersection ID: 42469 Mai | Main Street: KINGSLEY_VIEW_DR | | Cross Street: CASTLE_WATCH_AV | | | | Location: | S | |
|---|---|---|---|---|---|---|---|---|--|
| | Remove & Replace Curb Ramp V | Nith | N/A | Ramp Length (in) | 115.0 | No | Ramp Slope (%) | 8.6 | |
| | Two New Directional Ramps or | | No | Ramp Width (in) | 35.0 | No | Ramp XSlope (%) | 5.6 | |
| | Not Found, R304.5.1, R304.2.2, | I | N/A | Gutter Lip Ht (in) | N/A | N/A | Gutter X Slope (%) | N/A | |
| | R304.5.3 | | N/A | Painted X Walk1? | No | N/A | Painted X Walk2? | No | |

| Intersection ID: 42469 Mai | Main Street: KINGSLEY_VIEW_DR | | Cross Street: CASTLE_WATCH_AV | | | | Location: | S | |
|---|---|---|---|---|---|---|---|---|--|
| | Equivalent. | I | N/A | Flare Type LT | N/A | N/A | Flare Type RT | N/A | |
