Access Compliance Report

Public Rights-of-Way (Curb Ramps)

Intersection ID: 10037582	Main Street: SELWYN FARMS LN	Cross Street: N/A	Location: NE
ADA ID: B752C9BBF132	Ramp Type: PerpDiag	Initial Pass/Fail: Fail	Overall Compliance: No
Severity Score: 46.25			
Codes/Mitigation Info/Possible Solution		Field Measurements/Component Compliance

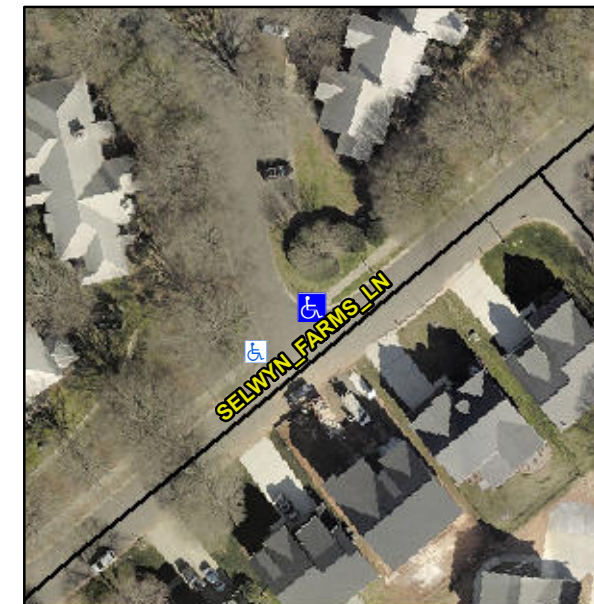
Not Found, R304.5.1, R304.2.2, R304.5.3

Compliance	Description	Data	Compliance	Description	Data
N/A	Ramp Length (in)	38.0	No	Ramp Slope (%)	11.9
No	Ramp Width (in)	47.0	No	Ramp XSlope (%)	12.1
N/A	Flare Type LT	N/A	N/A	Flare Type RT	N/A
N/A	Flare Slope LT (%)	N/A	N/A	Flare Slope RT (%)	N/A
N/A	Flare Traversable LT?	N/A	N/A	Flare Traversable RT?	N/A
N/A	Landing Length (in)	N/A	N/A	DWS Provided?	N/A
N/A	Landing Width (in)	N/A	N/A	DWS Contrast?	N/A
N/A	Landing Slope (%)	N/A	N/A	DWS Length (in)	N/A
N/A	Landing X Slope (%)	N/A	N/A	DWS Full Width?	N/A
N/A	Landing Curb? (Y/N)	N/A	N/A	DWS Offset (in)	N/A
N/A	Shared Landing?	N/A			
N/A	Gutter Ponding?	N/A	N/A	Gutter Slope (%)	N/A
N/A	Gutter Lip Ht (in)	N/A	N/A	Gutter X Slope (%)	N/A
N/A	Painted X Walk1?	No	N/A	Painted X Walk2?	No
	X Walk 1 Direction	To SW		X Walk 2 Direction	To SE
N/A	X Walk 1 Width (in)	N/A	N/A	X Walk 2 Width (in)	N/A
	X Walk 1 Slope (%)	0.0		X Walk 2 Slope (%)	6.3
	X Walk 1 X Slope (%)	5.6		X Walk 2 X Slope (%)	1.8

N/A	Ramp inside XWalk1?	N/A	N/A	Ramp inside XWalk2?	N/A
	Road Slope (%)	7.0	N/A	Clear Space?	N/A
	Road X Slope (%)	3.2	N/A	Clear Space to XWalk (in)	N/A
N/A	Any Obstructions?	N/A	N/A	Storm Grate/Utility Hazard?	N/A
	Obstruction Type			Storm Grate/Utility Type	
		N/A			N/A
			Yes	Surface Condition? (G/P)	Good

Remove & Replace Curb Ramp With Two New Directional Ramps or Equivalent.
