Access Compliance Report

Public Rights-of-Way

(Curb Ramps)

Intersection ID: 22250	Main Street: SHARON_LAKES_RD	Cross Street: SOUTH_BV	Location: SE
ADA ID: B753AD433391	Ramp Type: Perp	Initial Pass/Fail: Fail	Overall Compliance: No
Severity Score: 22.5			
Codes/Mitigation Info/Possible Solution		Field Measurements/Component Compliance

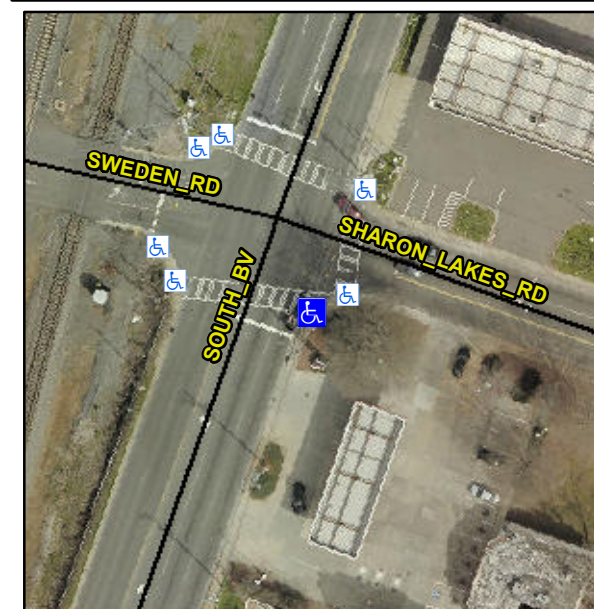
Not Found, R304.5.1, R304.2.2, R304.5.3

Compliance	Description	Data	Compliance	Description	Data
N/A	Ramp Length (in)	58.0	No	Ramp Slope (%)	11.7
No	Ramp Width (in)	45.0	No	Ramp XSlope (%)	3.8
N/A	Flare Type LT	N/A	N/A	Flare Type RT	N/A
N/A	Flare Slope LT (%)	N/A	N/A	Flare Slope RT (%)	N/A
N/A	Flare Traversable LT?	N/A	N/A	Flare Traversable RT?	N/A
N/A	Landing Length (in)	N/A	N/A	DWS Provided?	N/A
N/A	Landing Width (in)	N/A	N/A	DWS Contrast?	N/A
N/A	Landing Slope (%)	N/A	N/A	DWS Length (in)	N/A
N/A	Landing X Slope (%)	N/A	N/A	DWS Full Width?	N/A
N/A	Landing Curb? (Y/N)	N/A	N/A	DWS Offset (in)	N/A
N/A	Shared Landing?	N/A			
N/A	Gutter Ponding?	N/A	N/A	Gutter Slope (%)	N/A
N/A	Gutter Lip Ht (in)	N/A	N/A	Gutter X Slope (%)	N/A
N/A	Painted X Walk1?	Yes	N/A	Painted X Walk2?	N/A
	X Walk 1 Direction	To W		X Walk 2 Direction	N/A
N/A	X Walk 1 Width (in)	122.0	N/A	X Walk 2 Width (in)	N/A
	X Walk 1 Slope (%)	2.8		X Walk 2 Slope (%)	N/A
	X Walk 1 X Slope (%)	0.1		X Walk 2 X Slope (%)	N/A

N/A	Ramp inside XWalk1?	Yes	N/A	Ramp inside XWalk2?	N/A
	Road Slope (%)	N/A	N/A	Clear Space?	N/A
	Road X Slope (%)	N/A	N/A	Clear Space to XWalk (in)	N/A
N/A	Any Obstructions?	N/A	N/A	Storm Grate/Utility Hazard?	N/A
	Obstruction Type			Storm Grate/Utility Type	
		N/A			N/A
			Yes	Surface Condition? (G/P)	Good

Possible Solutions:

Remove & Replace Entire Ramp.

Total Cost: \$ 1850.00
